**VOLKSWAGEN TIGUAN: 1EGC429**

**Limited Technical Inspection**

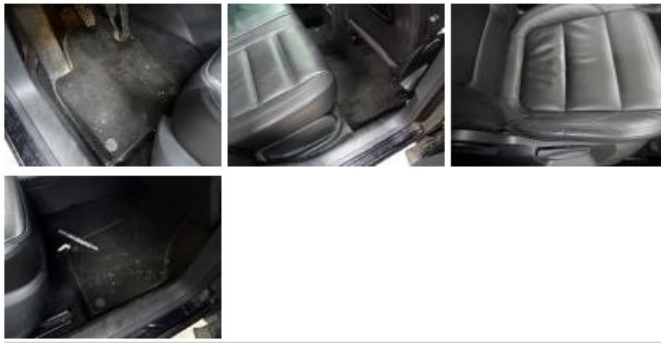
Interior, Dirty, Cleaning	100,00
---------------------------	--------
