## VOLVO V40: 1FRV261

## Limited Technical Inspection

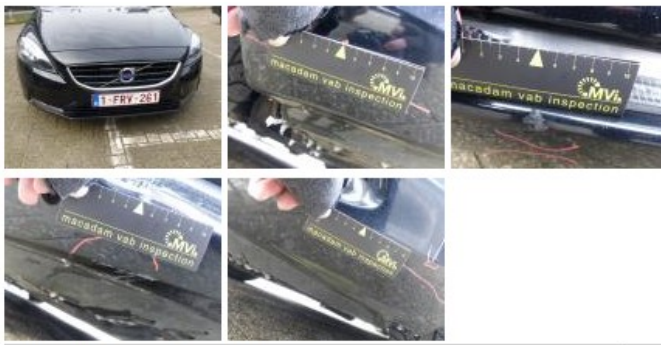
Front bumper, Scratch(es), LI - Repair and paint (complete)	211,80
---	--------
