TOYOTA AURIS TOURING SPORTS: 1NBT968

Limited Technical Inspection

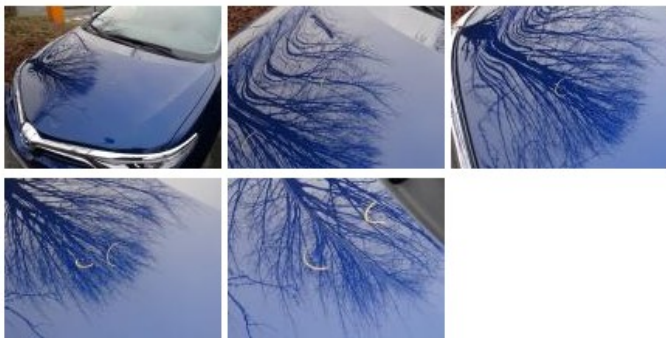
Total cost ex VAT	1690,00
Bonnet, Hail damage, PDR - Hail	500,00
