BMW 520: 1DWT814

| Vinnumber: | WBAFW91000DW47919 | Versionname: | 5 BER 520d |

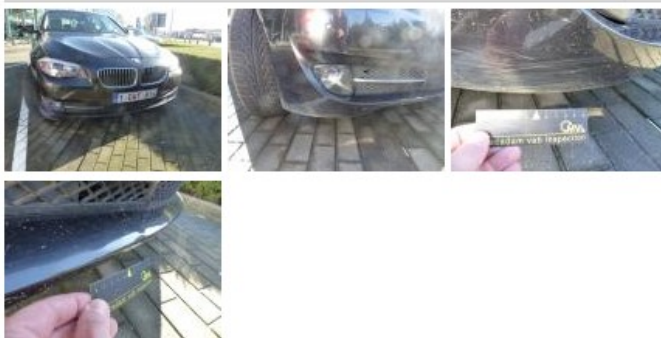
| Front bumper, Bump(s) and scratch(es), LI - Repair and paint (complete) | 302,16 |

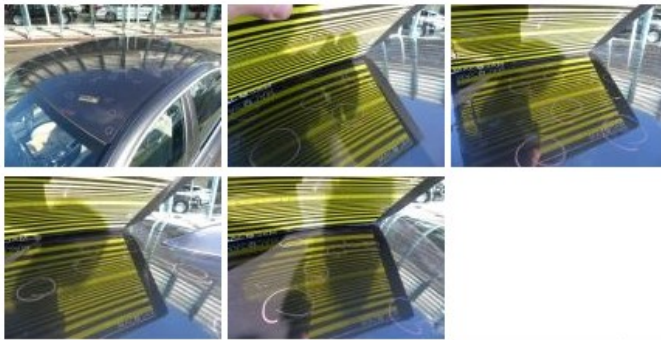
Roof, Hail damage, PDR - Hail 0,00

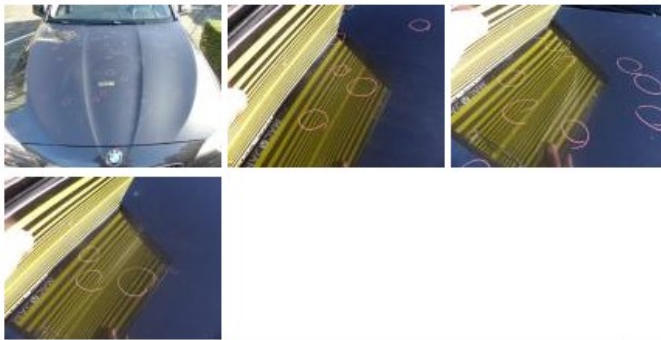
Bonnet, Hail damage, PDR - Hail 0,00
