BMW 5: 1CLZ500

Limited Technical Inspection

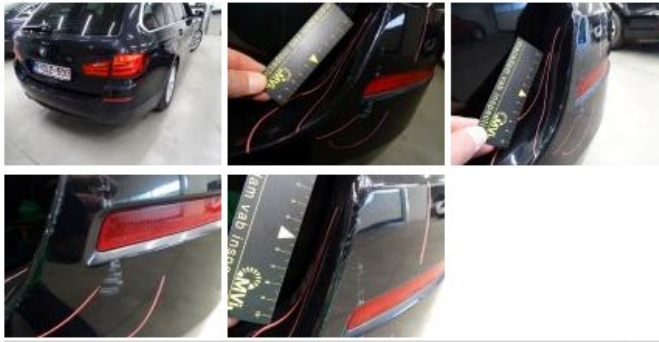
Bumper R, Crack, Le - Replace and paint

766,80
