BMW 318: 1JUL986

Limited Technical Inspection

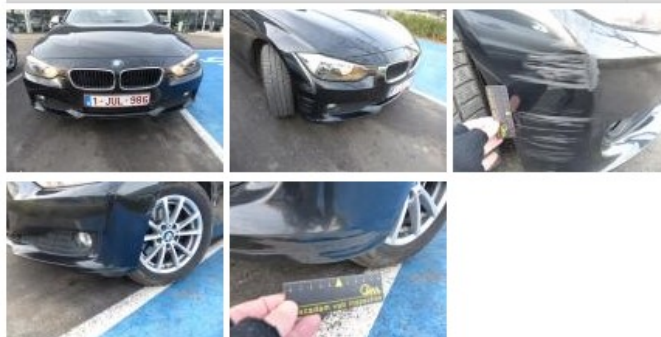
Front bumper, Scratch(es), LI - Repair and paint (complete)	211,80
---	---------------
