VOLKSWAGEN Crafter 35 MWB: 539BVP			
Vinnnumber:	<b>WV1ZZZ2FZA7003947</b>	Versionname:	<b>CRAFTER 35 LB2C MWB 109PK</b>
First Registrationdate:	<b>12/07/2010</b>	Fiscalpower:	
Expertise Mileage:	<b>246384</b>	Power Kw:	<b>80</b>
Bodytype:	<b>Transporter</b>	Body color:	<b>White</b>
Gearbox:	<b>MAN 6 VIT</b>	Paint type:	<b>Opaque</b>
Transmission:		Rims summer:	<b>Steel</b>
Fueltype:	<b>Diesel</b>	Oil level:	<b>OK</b>
Battery functioning:	<b>Yes</b>	Parking lot:	<b>LCV13</b>
Number of doors:	<b>4</b>		
Number of seats:	<b>7</b>		
Number head rests:	<b>7</b>		
Rims summer:	<b>Steel</b>		
Category:	<b>Light Commercial Vehicle</b>		
Oil level:	<b>OK</b>

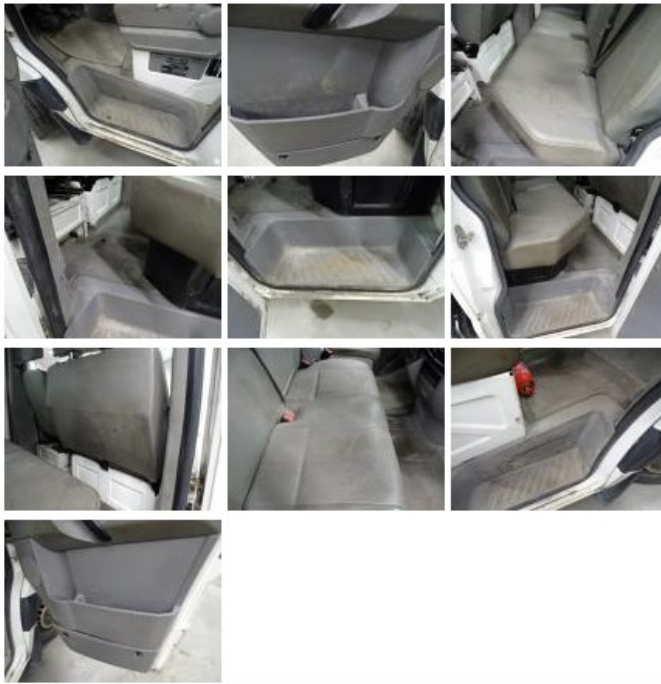
Interior, Dirty, Cleaning 150,00

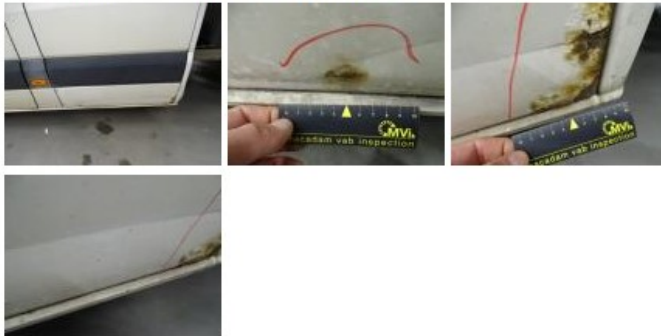
Door R L, Rust, LI - Repair and paint (complete) 238,76
