VOLKSWAGEN Golf Plus: 1E0S657

Limited Technical Inspection

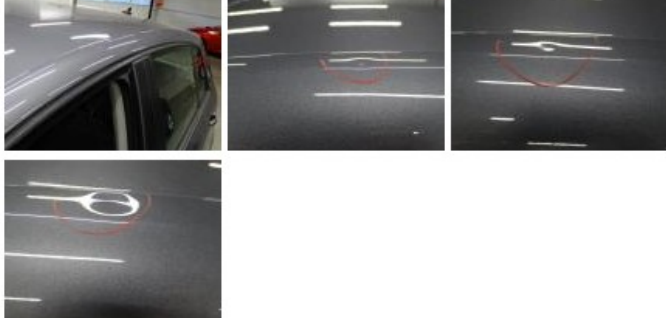
Roof pillar L, Hail damage, PDR - Hail	0,00
---	-------------

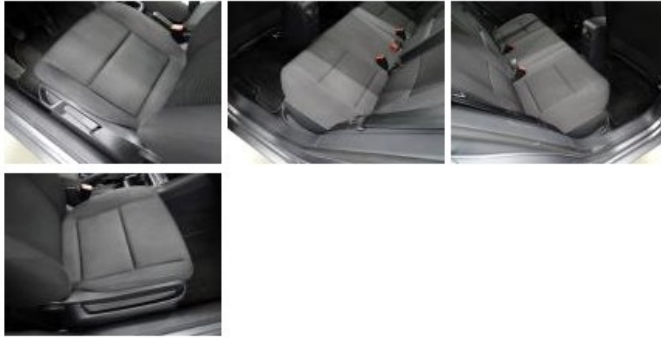
Interior, Dirty, Cleaning 100,00

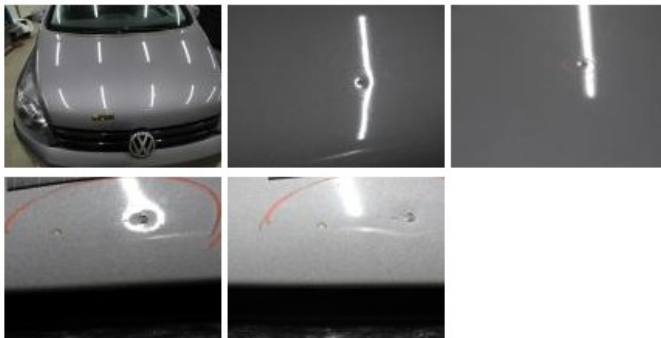
Bonnet, Bump(s) and scratch(es), LI - Repair and paint (complete) 290,08

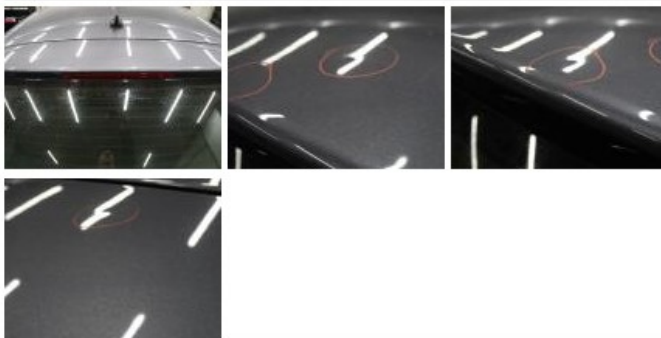
Tailgate, Hail damage, PDR - Hail 0,00

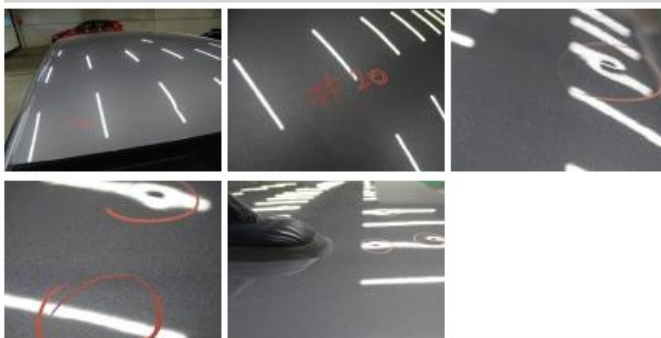
Roof, Hail damage, PDR - Hail 0,00

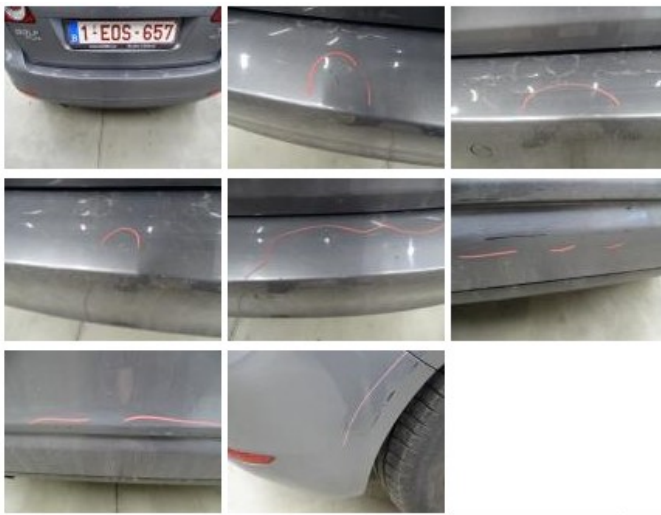
Bumper R, Scratch(es), LI - Repair and paint (complete) 211,80

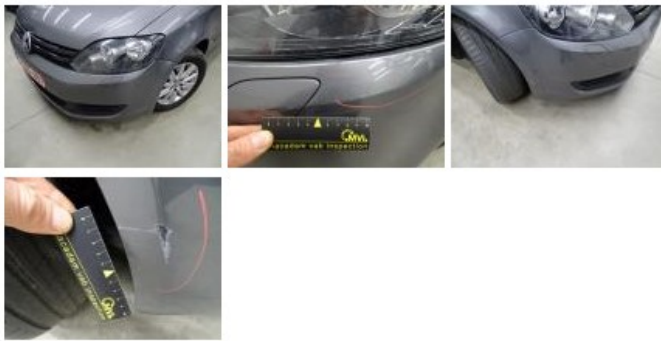
Front bumper, Scratch(es), LI - Repair and paint (complete) 211,80
