SKODA Superb: 1FGE768

Limited Technical Inspection

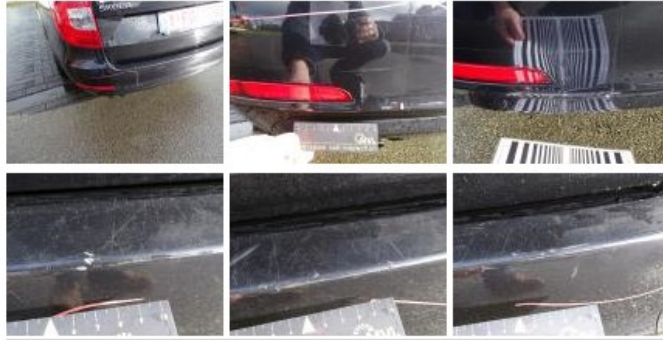
Bumper R, Bump(s) and scratch(es), LI - Repair and paint (complete) 302,16

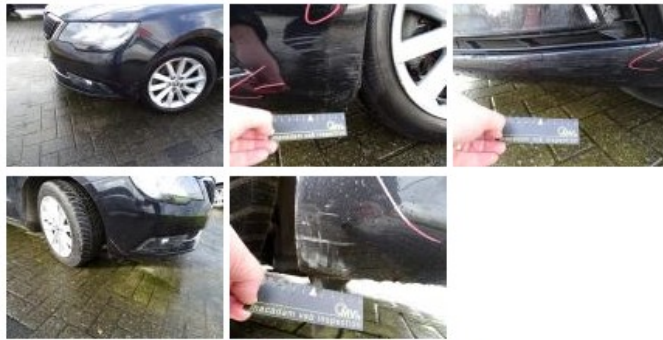
Front bumper, Scratch(es), LI - Repair and paint (complete) 254,16

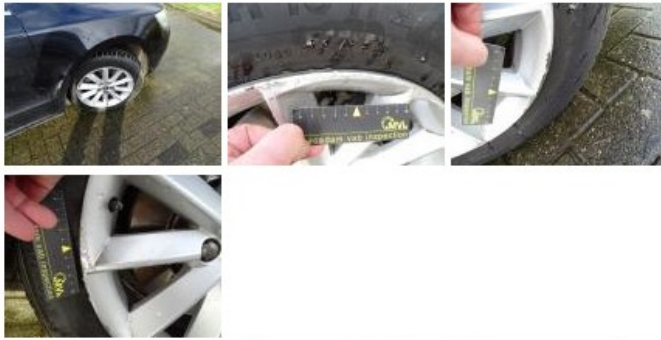
Alloy rim F R, Scratch(es), LI - Repair and paint (complete) 95,00
