VOLKSWAGEN TOURAN: 1DQ0707

Limited Technical Inspection

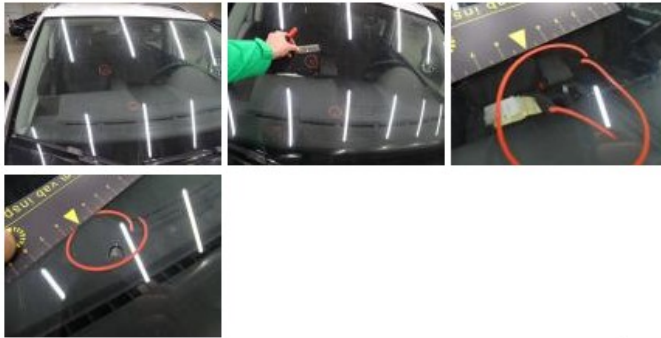
Windscreen, Stone chip(s), Windscreen repair 88,20

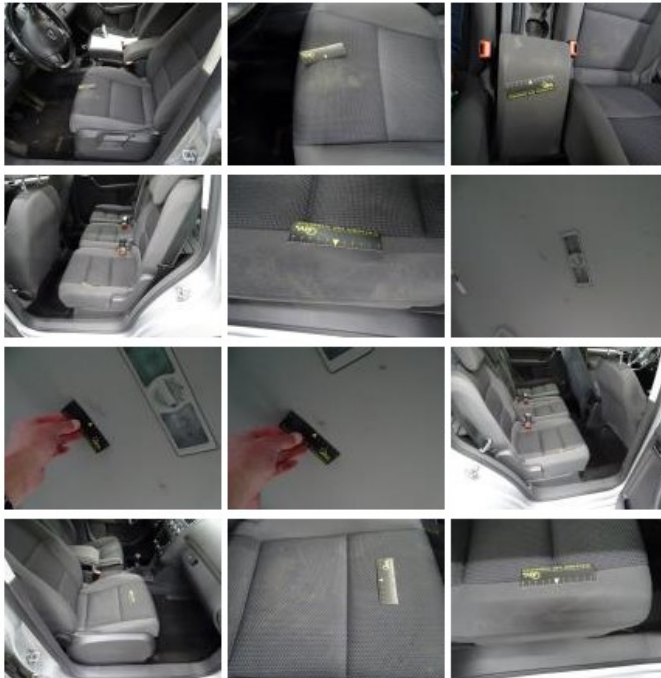
Interior, Stain, Cleaning 125,00

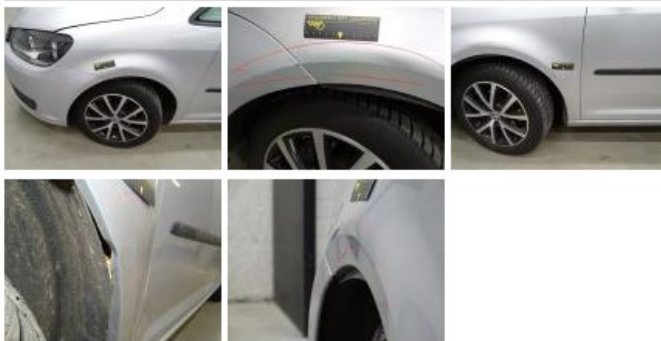
Alloy rim F R polished, Scratch(es), Acceptable	0,00
<i>No pictures to display</i>	
Wing F L, Bump(s) and scratch(es), Le - Replace and paint	530,02
