## VOLVO S80: 1EHW133

## Limited Technical Inspection

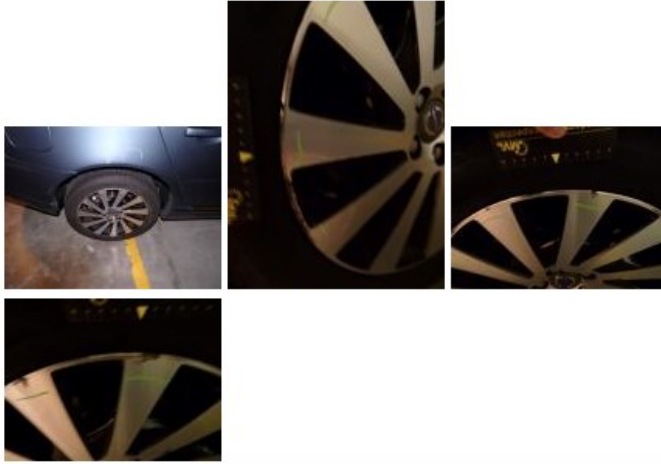
Alloy rim R R polished, Scratch(es), LI - Repair and paint (complete) 95,00

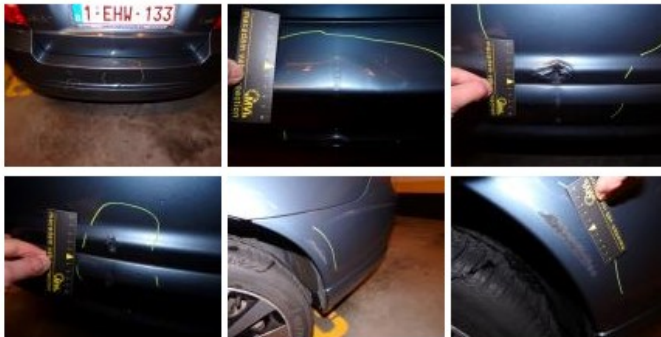
Bumper R, Damaged, Le - Replace and paint 766,80
