VOLVO V40: 1FSB534

Limited Technical Inspection

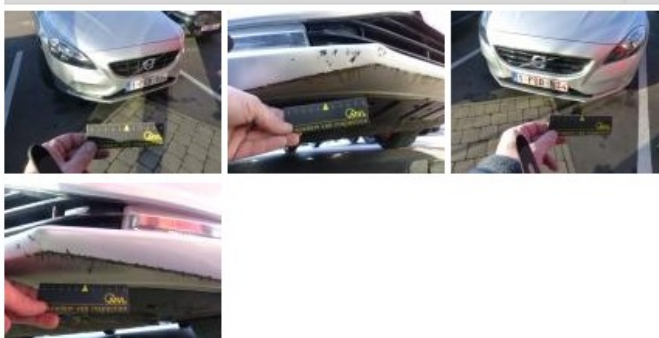
Front bumper, Scratch(es), LI - Repair and paint (complete)	211,80
---	---------------
