## VOLVO V60: 1FKW835

## Limited Technical Inspection

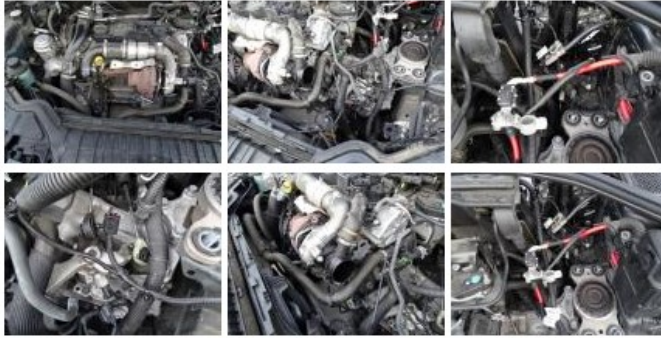
Engine, Missing, P - Check 0,00
