AUDI A6: 1HTJ405

Limited Technical Inspection

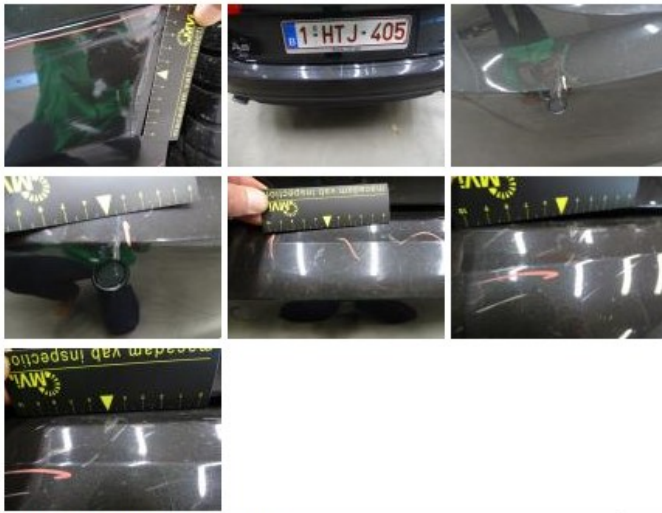
Bumper R, Scratch(es), LI - Repair and paint (complete)
