FORD Mondeo: 1FRG647			
Vinnumber:	WF0GXXGBBGDG58614	Versionname:	MONDEO CLIP EConet.Titanium Style 115PK
First Registrationdate:	1/10/2013	Fiscalpower:	85
Expertise Mileage:	131217	Power Kw:	85
Bodytype:	MAN 6 VIT	Body color:	Silver
Gearbox:	Back	Paint type:	Metalic
Transmission:	Back	Rims summer:	Aluminium
Fueltype:	Diesel	Oil level:	OK
Battery functioning:	Yes	Parking lot:	3619
Number of doors:	5		
Number of seats:	5		
Number head rests:	5		
Rims summer:	Aluminium		
Category:	Passenger Car		
Oil level:	OK		
Registration Certificate Car (BE):	Yes

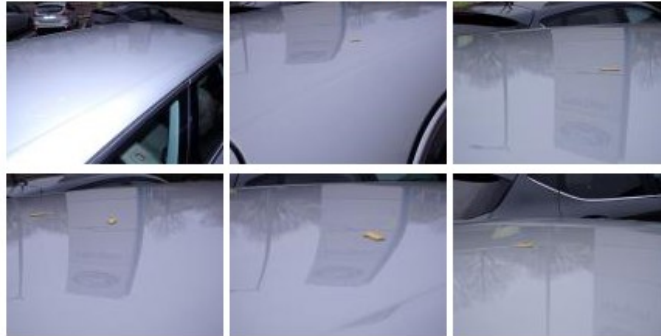
Roof, Hail damage, PDR - Knock out without painting 201,60
