CITROEN C4 Picasso: 1FKE634

Limited Technical Inspection

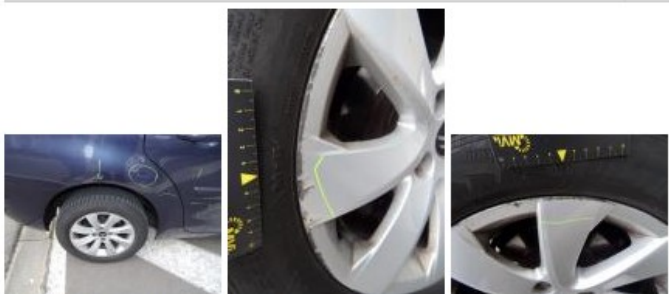
Total cost ex VAT	1614,22
Alloy rim R R, Scratch(es), LI - Repair and paint (complete)	95,00

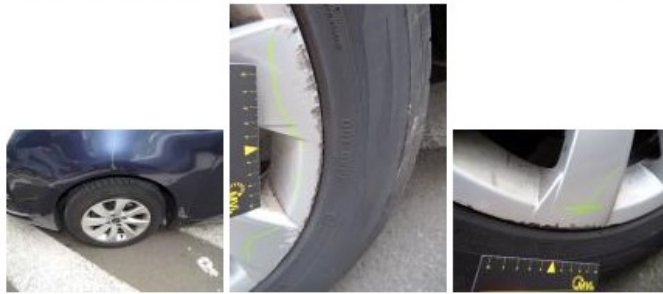
Alloy rim F L, Scratch(es), LI - Repair and paint (complete) 95,00

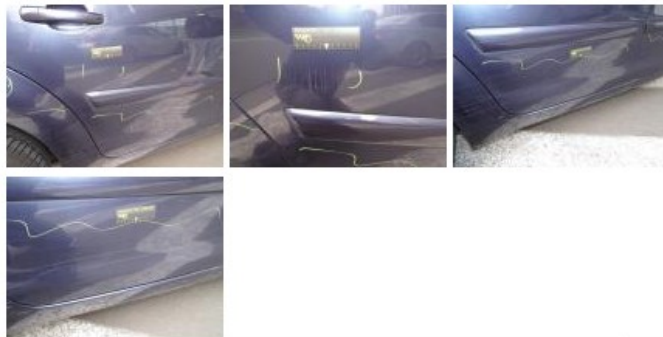
Door R R, Scratch(es), 67 - Polish 55,19

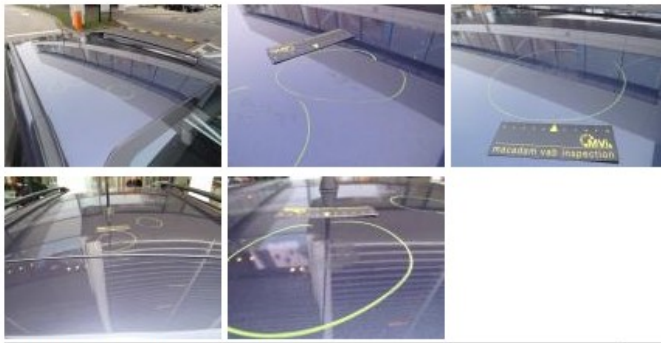
Roof, Chemical pollution, LI - Repair and paint (complete) 481,50

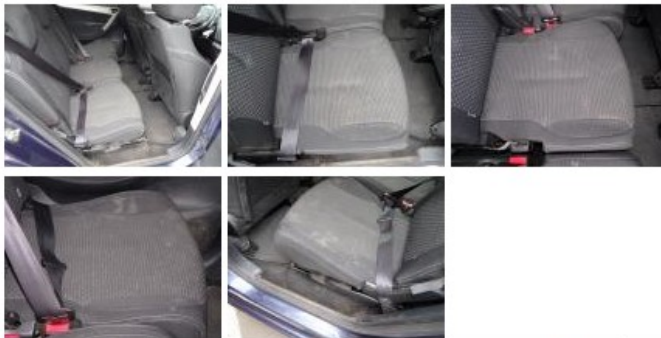
Interior, Dirty, Forfeit 100,00

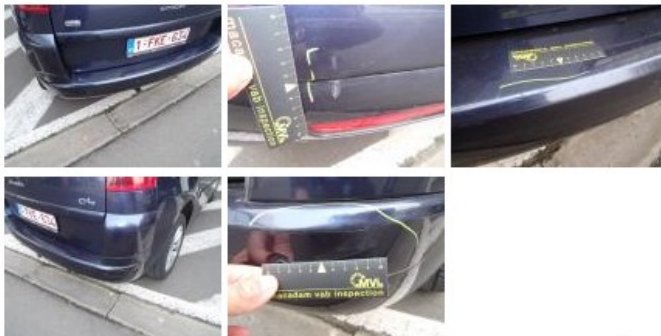
Bumper R, Bump(s) and scratch(es), LI - Repair and paint (complete) 211,80
