**OPEL Zafira: 1GGO043**

**Limited Technical Inspection**

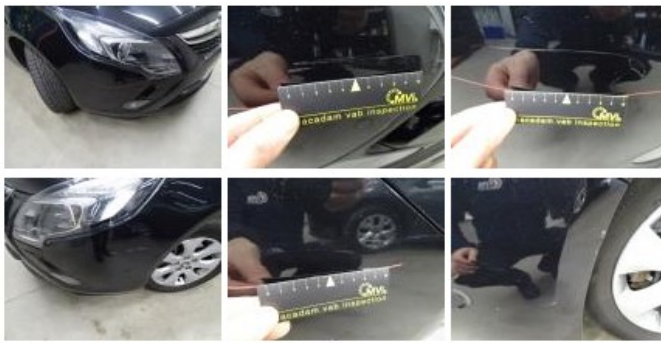
Door R R, Scratch(es), Acceptable	0,00
<i>No pictures to display</i>	
Ignition key, Missing, E - Replace	150,00
<i>No pictures to display</i>	
Front bumper, Scratch(es), LI - Repair and paint (complete)	211,80

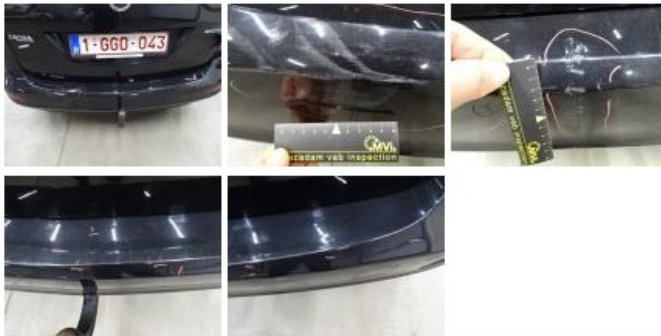
Bumper R, Bump(s) and scratch(es), LI - Repair and paint (complete) 211,80
