VOLKSWAGEN Touran: 1GIL217

| Vinnnumber: | WVGZZ1TZEW060692 | Versionname: | TOURAN Trendline BMT |

Limited Technical Inspection

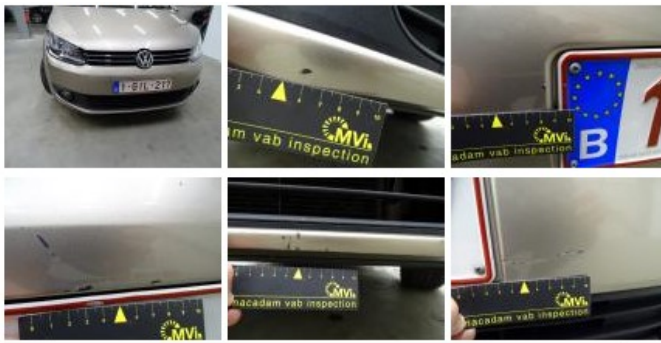
| Front bumper, Scratch(es), LI - Repair and paint (complete) | 211,80 |

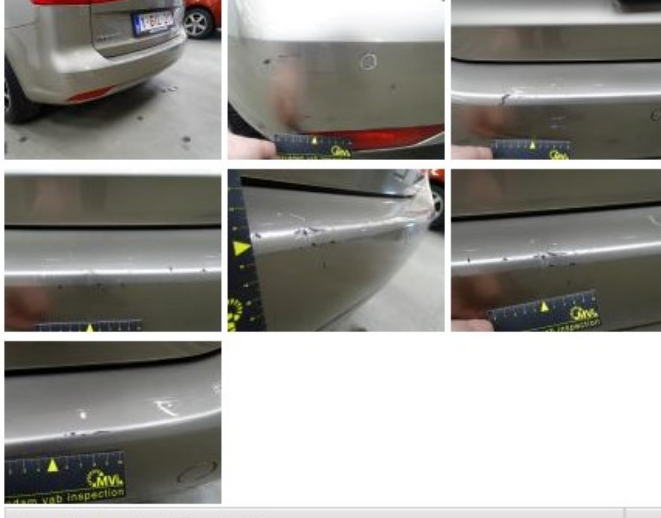
Bumper R, Bump(s) and scratch(es), LI - Repair and paint (complete) 259,80
