MERCEDES CLA: 1FNJ692			
Vinnnumber:	WDD1173011N030236	Versionname:	CLA BER 200 CDI 136PK
First Registrationdate:	28/08/2013	Fiscalpower:	
Expertise Mileage:	72767	Power Kw:	100
Bodytype:		Body color:	Silver
Gearbox:	Automatic	Paint type:	Metalic
Transmission:	Back	Rims summer:	Aluminium
Fueltype:	Diesel	Oil level:	OK
Battery functioning:	Yes	Parking lot:	2831
Number of doors:	5		
Number of seats:	5		
Number head rests:	5		
Rims summer:	Aluminium		
Category:	Passenger Car		
Oil level:	OK

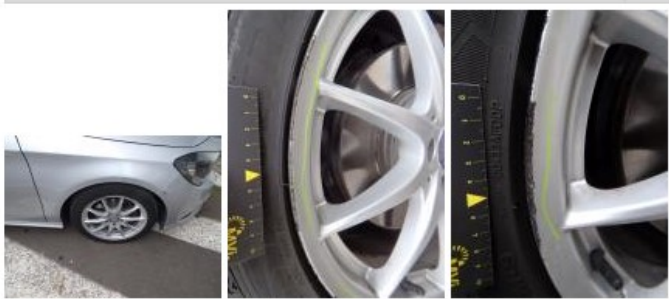
Assistance equipment	
Repair kit	Yes
Compressor	Yes
Total cost ex VAT	712,30
Maintenance book, Missing, P - Check	0,00
<i>No pictures to display</i>	
Alloy rim F L, Scratch(es), Acceptable	0,00
<i>No pictures to display</i>	
Alloy rim F R, Scratch(es), LI - Repair and paint (complete)	95,00

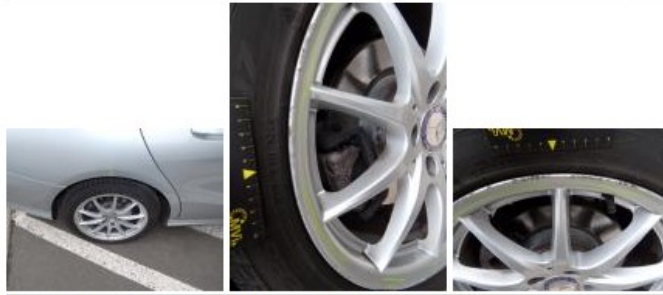
Tailgate, Scratch(es), Acceptable	0,00
<i>No pictures to display</i>	
Seat cover F R, Stain, Acceptable	0,00
<i>No pictures to display</i>	
Bumper moulding R, Scratch(es), Acceptable	0,00
<i>No pictures to display</i>	
Alloy rim R R, Scratch(es), LI - Repair and paint (complete)	95,00

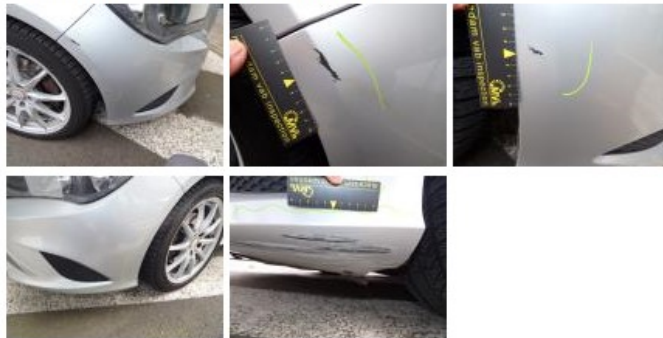
Front bumper, Scratch(es), LI - Repair and paint (complete)	211,80
---	--------
