BMW 1: 1HUA177

Limited Technical Inspection

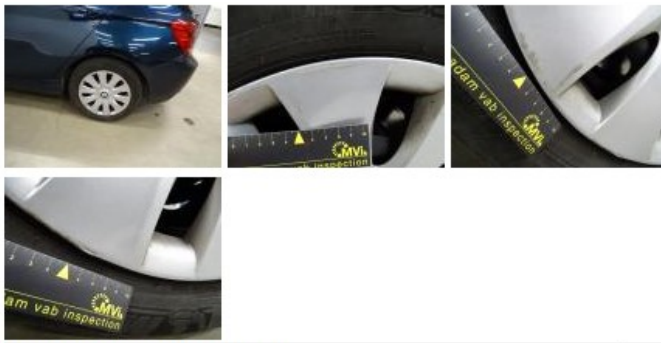
| Wheel cover R L, Scratch(es), E - Replace | 30,00 |

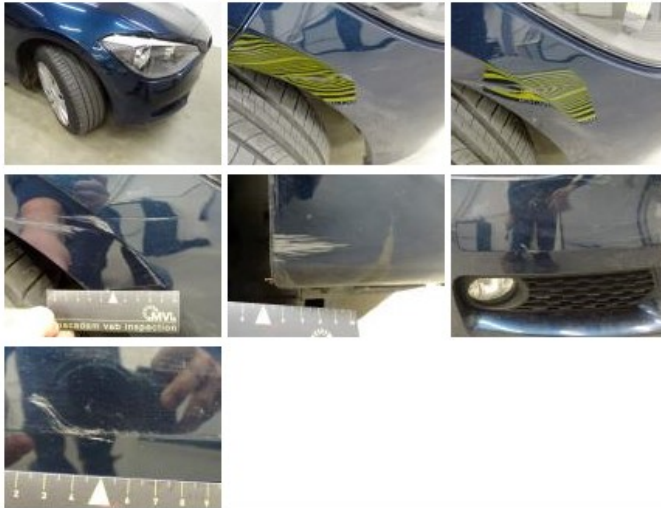
Front bumper, Bump(s) and scratch(es), LI - Repair and paint (complete) 283,80
