BMW 5: 1GDT134

Limited Technical Inspection

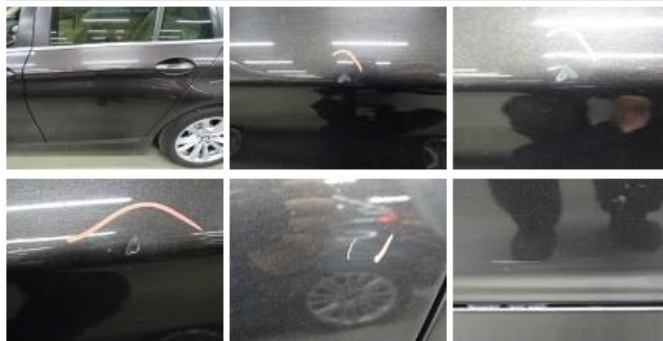
Door R L, Bump(s) and scratch(es), LI - Repair and paint (complete) 382,02

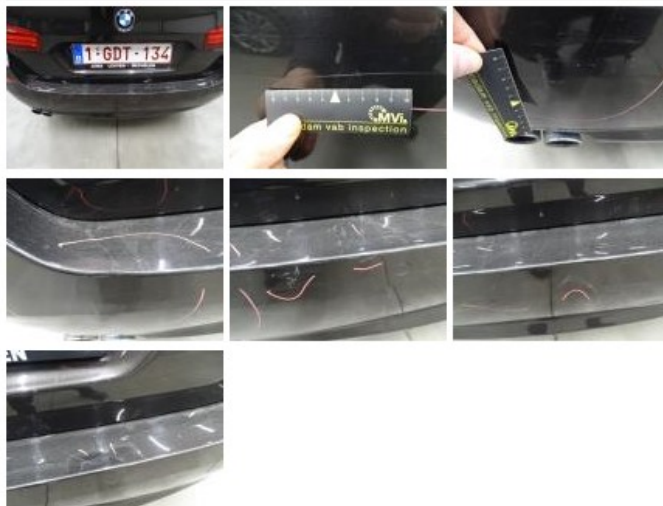
Bumper R, Bump(s) and scratch(es), LI - Repair and paint (complete) 254,16
