VOLVO V40: 1GHH727			
Vinnumber:	YV1MV8481E2133526	Versionname:	V40 D2 Base 115PK
First Registrationdate:	7/02/2014	Fiscalpower:	
Expertise Mileage:	128956	Power Kw:	84
Bodytype:		Body color:	Light Grey
Gearbox:	MAN 6 VIT	Paint type:	Metalic
Transmission:		Rims summer:	Aluminium
Fueltype:	Diesel	Oil level:	OK
Battery functioning:	Yes	Parking lot:	2603
Number of doors:	5		
Number of seats:	5		
Number head rests:	5		
Rims summer:	Aluminium		
Category:	Passenger Car		
Oil level:	OK		
Registration Certificate Car (BE):	Yes

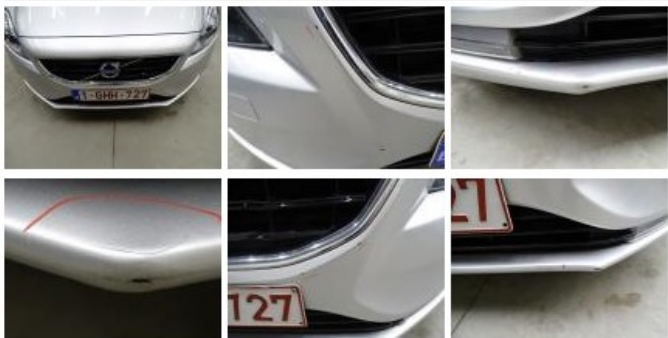
Front bumper, Scratch(es), LI - Repair and paint (complete)	211,80
