**AUDI A6: 1HFY176**

**Limited Technical Inspection**

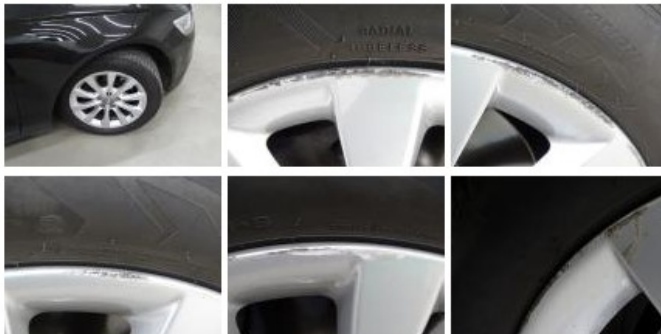
Alloy rim F R, Scratch(es), LI - Repair and paint (complete) 95,00

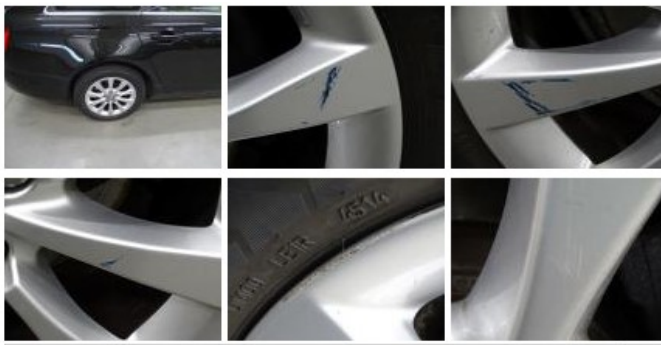
Alloy rim R R, Scratch(es), LI - Repair and paint (complete) 95,00

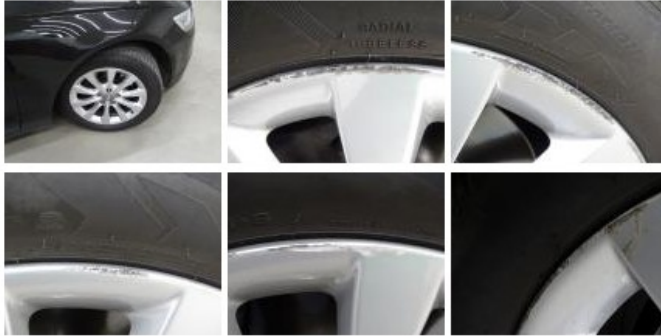
Alloy rim F R, Scratch(es), LI - Repair and paint (complete) 95,00
