BMW 5: 1DOW559

Limited Technical Inspection

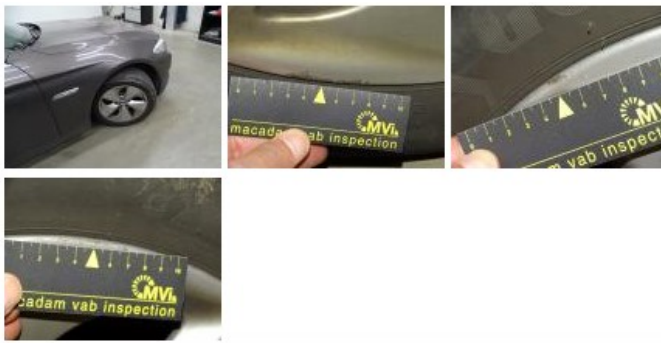
Alloy rim F R, Scratch(es), LI - Repair and paint (complete) 95,00

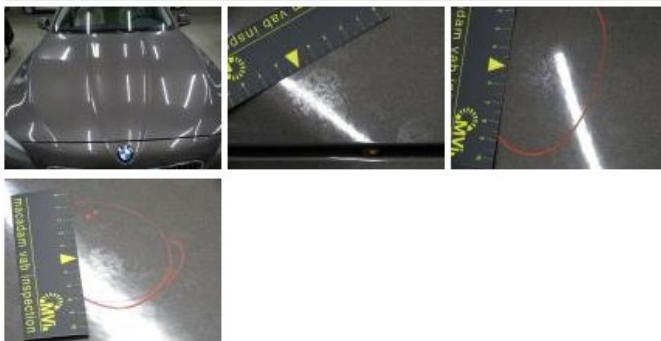
Bonnet, Chemical polution, LI - Repair and paint (complete) 348,09
