MITSUBISHI ASX: 1FKE997			
Vinnumber:	<b>JMBXJGA6WDZ407212</b>	Versionname:	<b>2WD Instyle</b>
First Registrationdate:	<b>24/07/2013</b>	Fiscalpower:	
Expertise Mileage:	<b>73039</b>	Power Kw:	<b>85</b>
Bodytype:		Body color:	<b>Brown</b>
Gearbox:	<b>MAN 6 VIT</b>	Paint type:	<b>Metalic</b>
Transmission:	<b>Front</b>	Rims summer:	<b>Aluminium</b>
Fueltype:	<b>Diesel</b>	Oil level:	<b>OK</b>
Battery functioning:	<b>Yes</b>	Parking lot:	<b>1118</b>
Number of doors:	<b>5</b>		
Number of seats:	<b>5</b>		
Number head rests:	<b>5</b>		
Rims summer:	<b>Aluminium</b>		
Category:	<b>Passenger Car</b>		
Oil level:	<b>OK</b>		
Registration Certificate Car (BE):	<b>No</b>

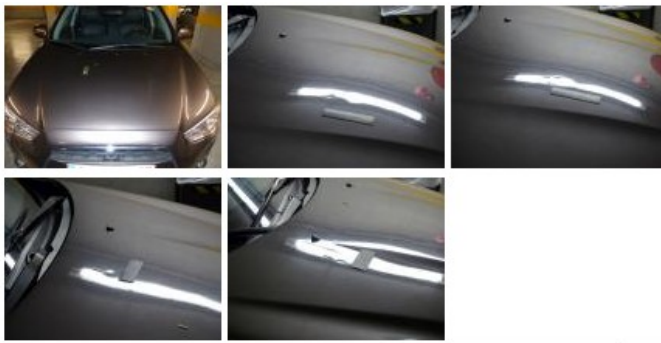
Bonnet, Bump(s), LI - Repair and paint (complete)			<b>338,08</b>

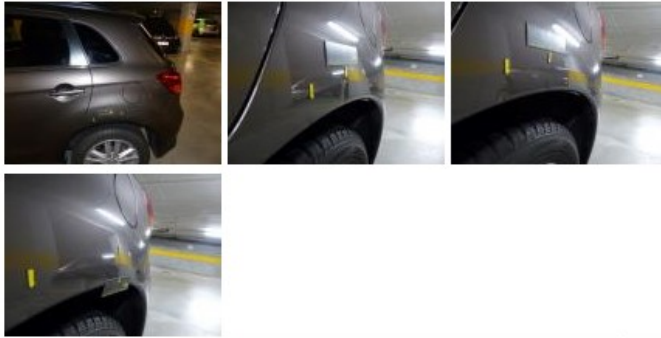
Wing R L, Bump(s), LI - Repair and paint (complete) 356,20

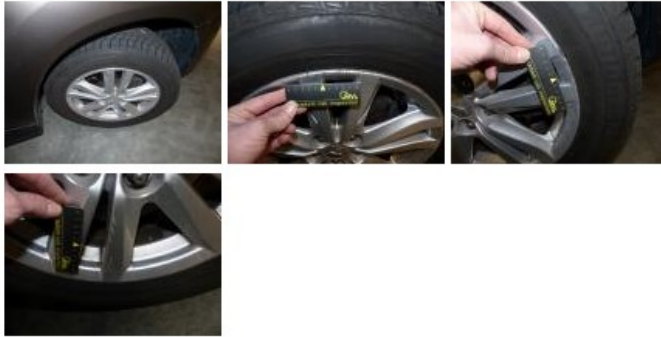
Alloy rim F R, Scratch(es), LI - Repair and paint (complete) 95,00
