| PEUGEOT 508SW: 1FBT388 | | | |
| Vinnnumber: | VF38E9HL0DL024317 | Versionname: | 1.6 HDI SW Active 115PK |

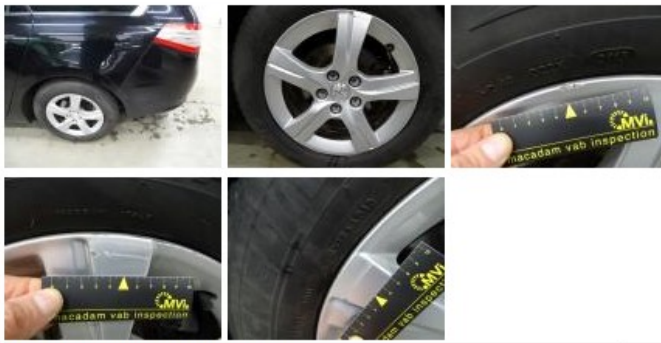
| Alloy rim R L, Scratch(es), LI - Repair and paint (complete) | 95,00 |

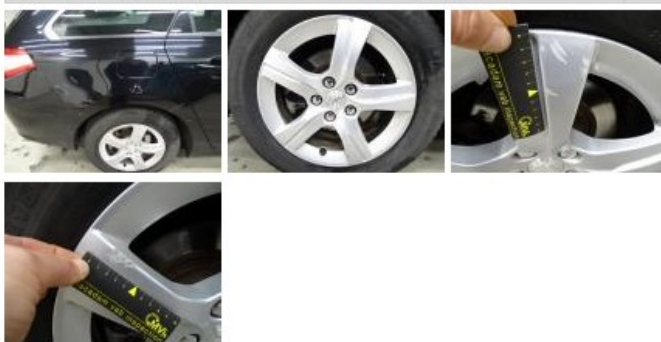
Alloy rim R R, Scratch(es), LI - Repair and paint (complete) 95,00

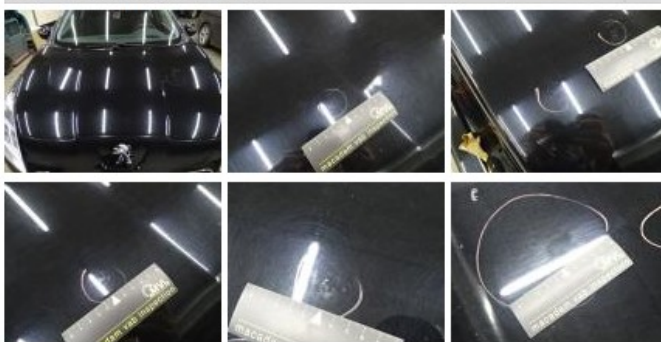
Bonnet, Bad repair, Acceptable 0,00

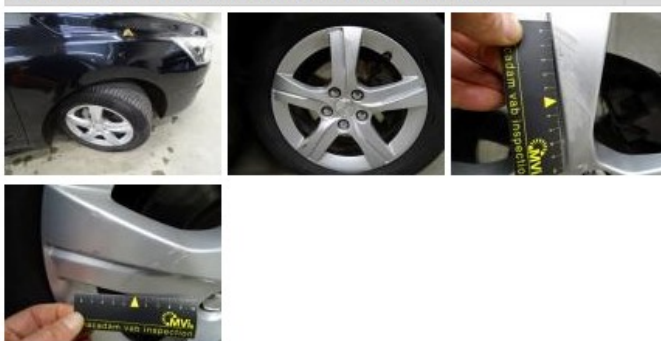
Alloy rim F R, Scratch(es), LI - Repair and paint (complete) 95,00
