VOLKSWAGEN Golf: 1GHC537

Limited Technical Inspection

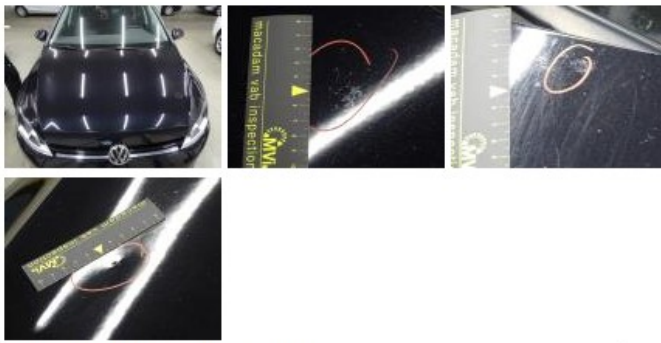
Bonnet, Chemical pollution, LI - Repair and paint (complete)	290,08
--	---------------

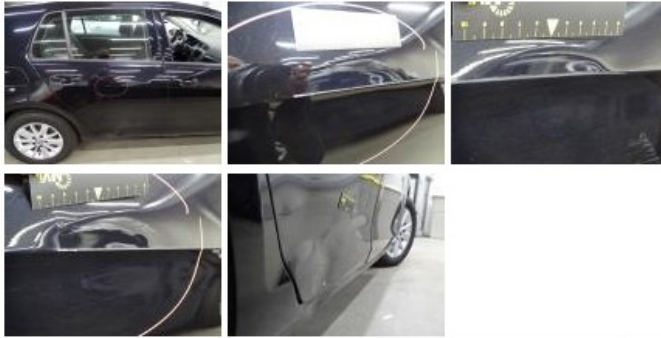
Door R R, Bump(s) and scratch(es), Le - Replace and paint 0,00

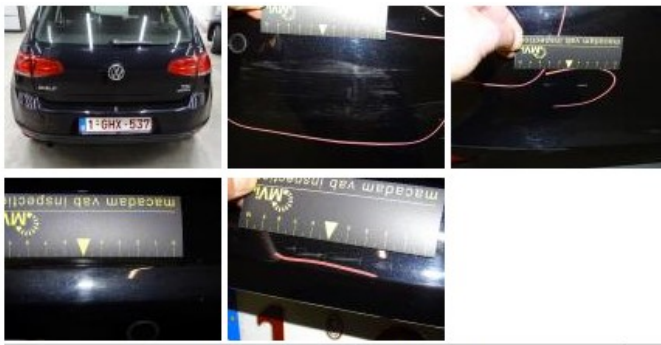
Bumper R, Scratch(es), LI - Repair and paint (complete) 211,80

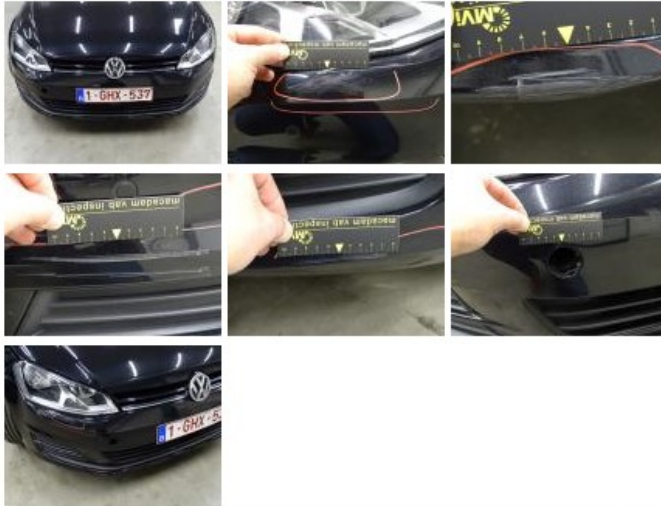
Front bumper, Scratch(es), LI - Repair and paint (complete) 226,80
