SKODA Octavia: 1ESU915

Limited Technical Inspection

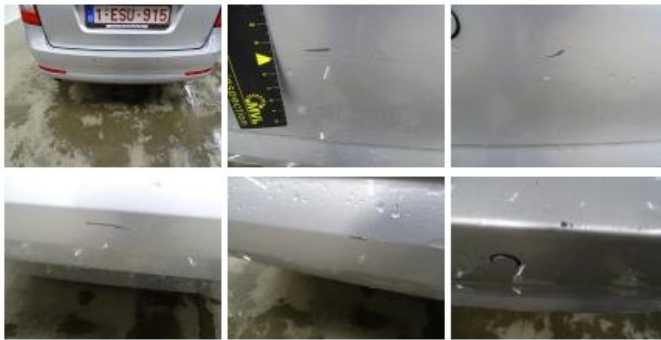
Bumper R, Scratch(es), LI - Repair and paint (complete) 211,80
