## VOLKSWAGEN Golf: 1HDK323

## Limited Technical Inspection

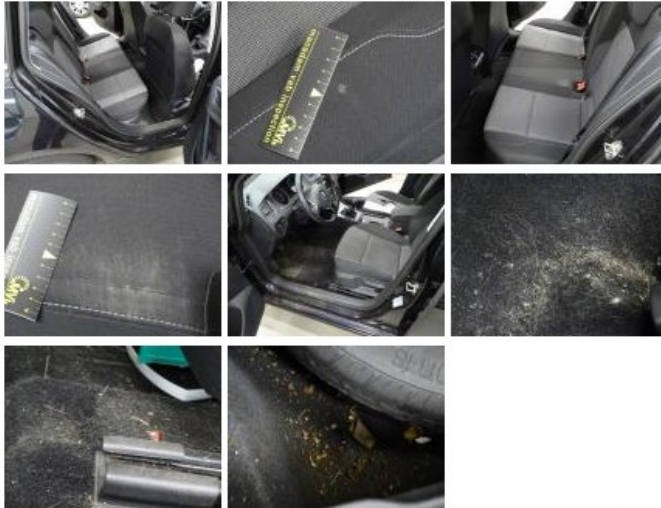
Interior, Dirty, Cleaning 100,00
