VOLVO V70: 1EKR984			
Vinnumber:	YV18W31A1D1262953	Versionname:	V70 D3 Kinetic St/St 136PK
First Registrationdate:	8/01/2013	Fiscalpower:	
Expertise Mileage:	161871	Power Kw:	100
Bodytype:	Break	Body color:	Dark Blue
Gearbox:	MAN 6 VIT	Paint type:	Metalic
Transmission:		Rims summer:	Aluminium
Fueltype:	Diesel	Oil level:	OK
Battery functioning:	Yes	Parking lot:	4119
Number of doors:	5		
Number of seats:	5		
Number head rests:	5		
Rims summer:	Aluminium		
Category:	Passenger Car		
Oil level:	OK

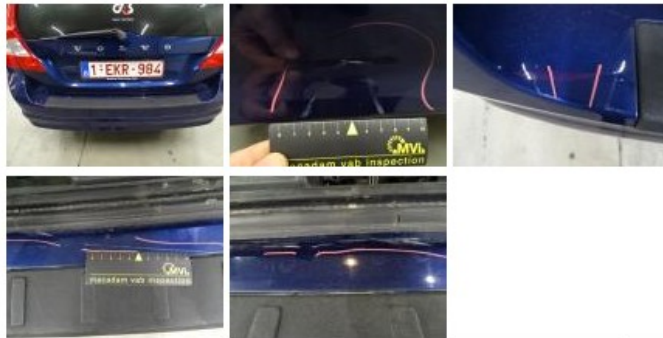
Bumper R, Bump(s) and scratch(es), LI - Repair and paint (complete) 254,16
