**LU Audi a3 Limousine: MK4208**

**Limited Technical Inspection**

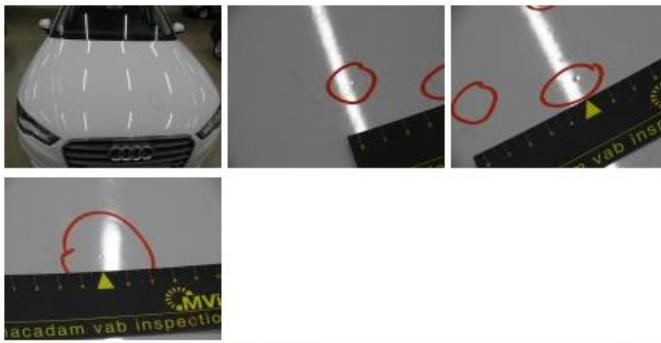
Wing F R, Scratch(es), Acceptable	0,00
<i>No pictures to display</i>	
Bonnet, Bad repair, Acceptable	0,00

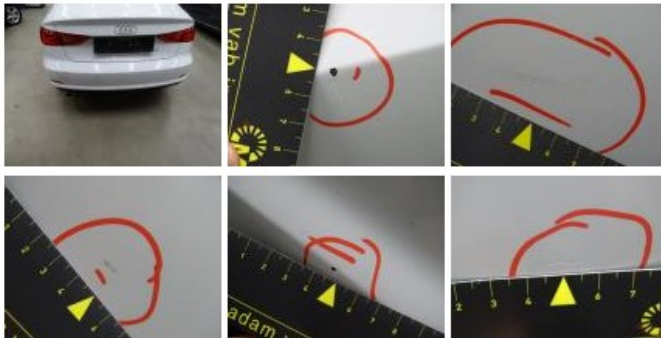
Bumper R, Scratch(es), LI - Repair and paint (complete)	211,80
---	--------
