## SKODA Octavia: 1ELB253

## Limited Technical Inspection

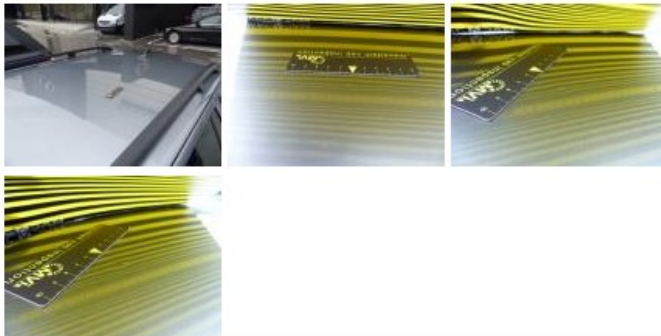
Roof, Hail damage, PDR - Hail 0,00

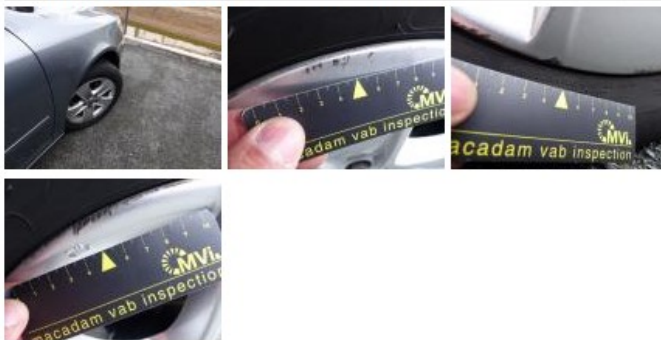
Alloy rim F R, Scratch(es), LI - Repair and paint (complete) 95,00
