VOLKSWAGEN Sharan: 1GFU882			
Vinnumber:	WVWZZZ7NZEV014765	Versionname:	SHARAN Trendline BMT
First Registrationdate:	28/01/2014	Fiscalpower:	136PK
Expertise Mileage:	150235	Power Kw:	100
Bodytype:		Body color:	Brown
Gearbox:	MAN 6 VIT	Paint type:	Metalic
Transmission:		Rims summer:	Steel
Fueltype:	Diesel	Oil level:	OK
Battery functioning:	Yes	Parking lot:	1233
Number of doors:	5		
Number of seats:	5		
Number head rests:	5		
Rims summer:	Steel		
Category:	Passenger Car		
Oil level:	OK		
Registration Certificate Car (BE):	Yes

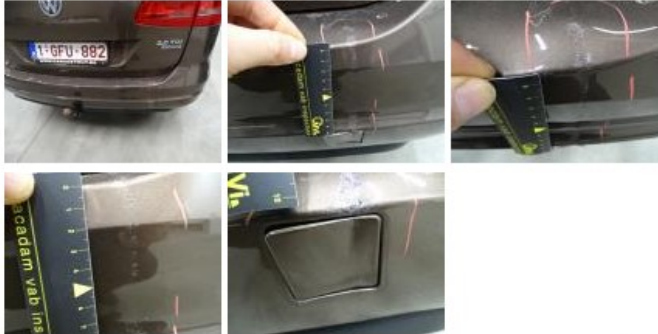
Bumper R, Bump(s) and scratch(es), LI - Repair and paint (complete) 254,16
