**VOLKSWAGEN Crafter 35 LWB: 993BKC**

**Limited Technical Inspection**

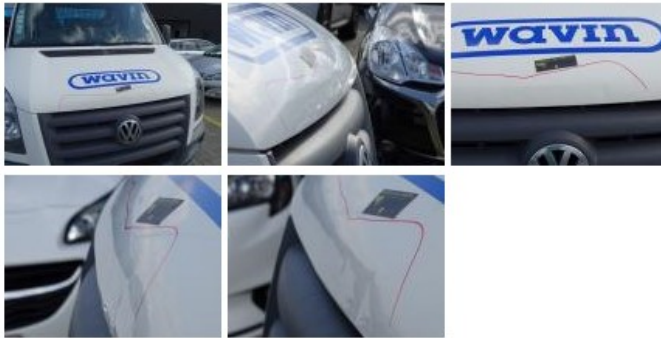
Bonnet, Bump(s), LI - Repair and paint (complete) 0,00

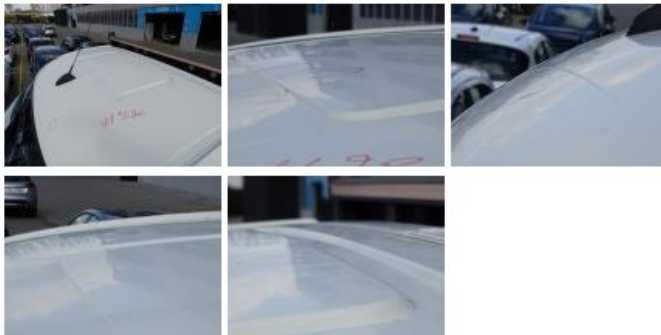
Roof, Hail damage, PDR - Hail 0,00
