## VOLVO S60: 1FWP286

## Limited Technical Inspection

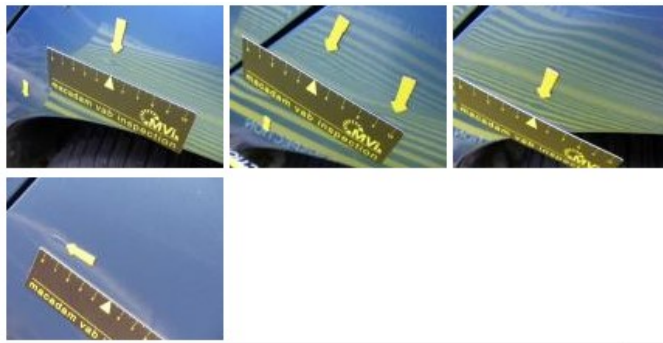
Wing R L, Bump(s) and scratch(es), LI - Repair and paint (complete)	308,20
---	--------

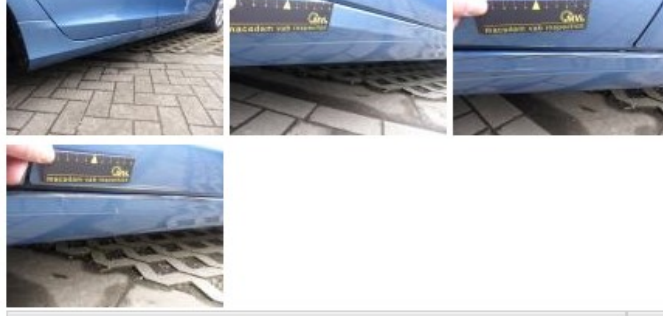
Sill trim R, Scratch(es), LI - Repair and paint (complete) 310,50

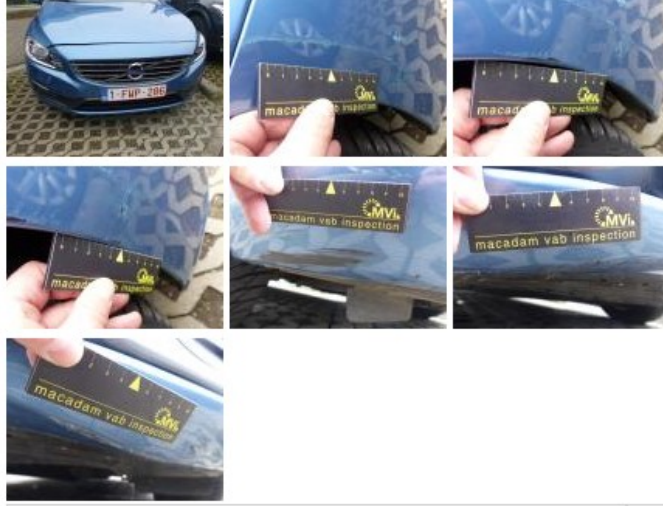
Front bumper, Scratch(es), LI - Repair and paint (complete) 211,80

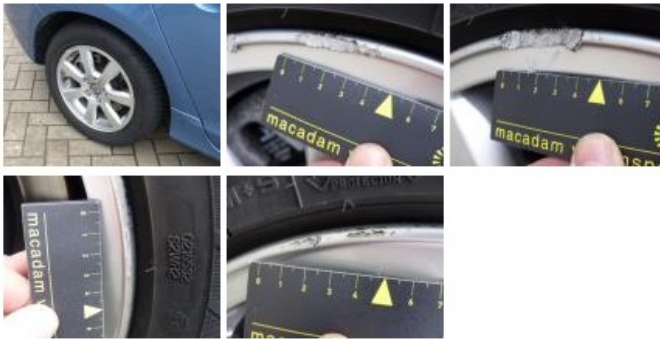
Alloy rim R R, Scratch(es), LI - Repair and paint (complete) 95,00

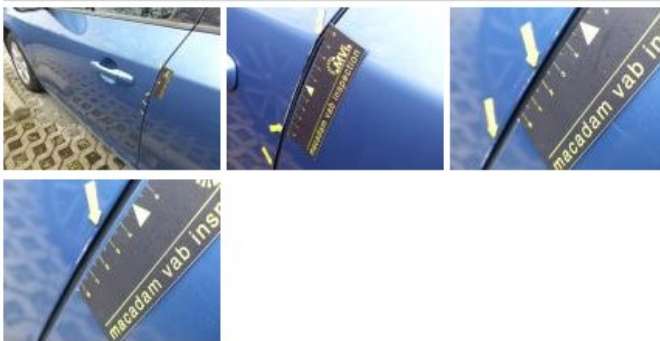
Door F L, Scratch(es), LI - Repair and paint (complete) 318,35

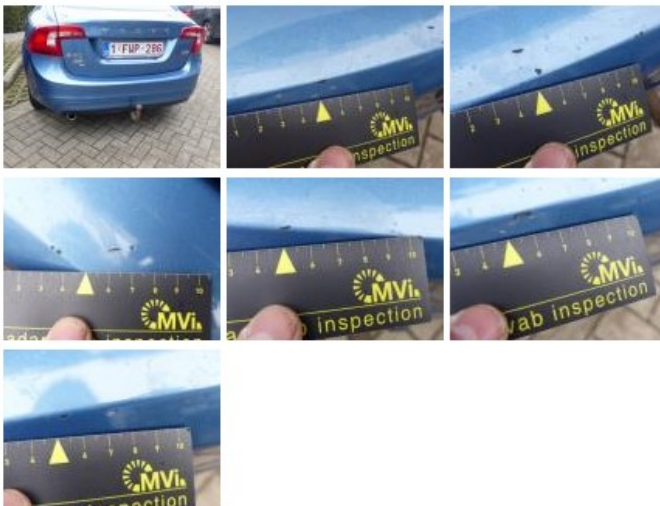
Bumper R, Scratch(es), LI - Repair and paint (complete) 211,80
