BMW X5: HK4623

Limited Technical Inspection

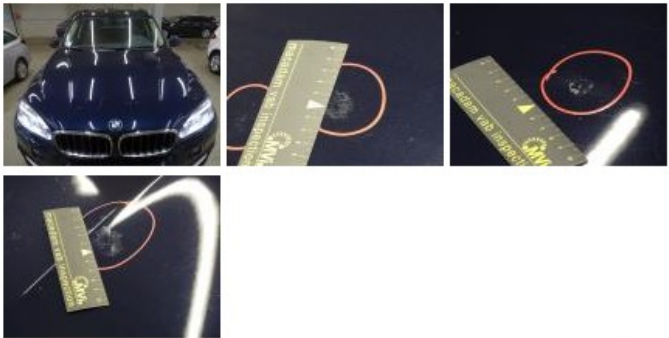
<i>No pictures to display</i>		
Bumper R, Scratch(es), Acceptable		0,00
<i>No pictures to display</i>		
Bonnet, Chemical polution, LI - Repair and paint (complete)		348,09

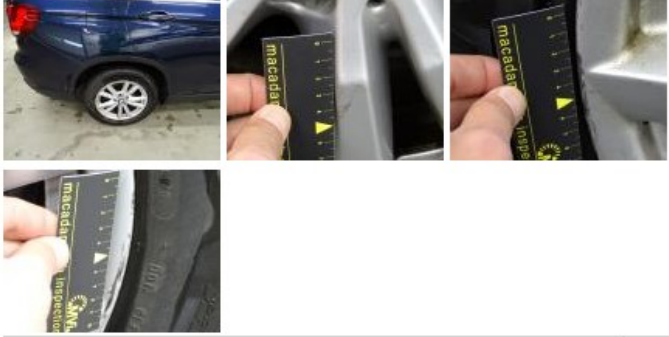
Front bumper, Scratch(es), Acceptable		0,00
<i>No pictures to display</i>		
Alloy rim R R, Scratch(es), LI - Repair and paint (complete)		95,00
