BMW 3: 1GCY625

Limited Technical Inspection

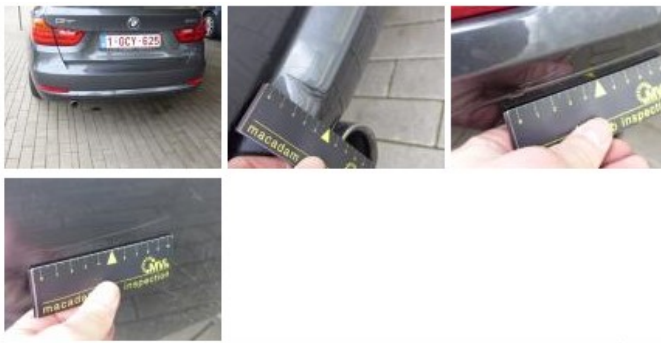
Bumper R, Bump(s) and scratch(es), LI - Repair and paint (complete)	211,80
---	---------------

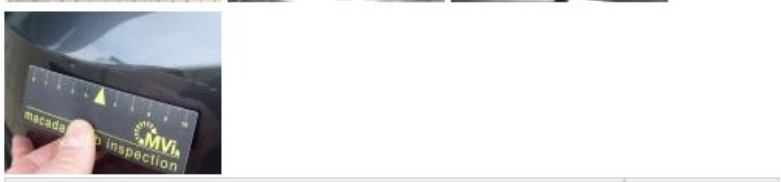
Front bumper, Scratch(es), LI - Repair and paint (complete) 211,80
