BMW 1: 1GEH048

Limited Technical Inspection

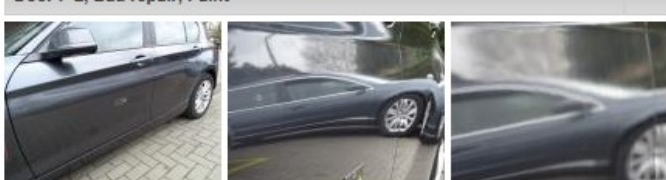
Door F L, Bad repair, Paint 0,00
