<b>CITROEN DS5: 1EBZ324</b>			
Vinnnumber:	<b>VF7KFRHC8CS520688</b>	Versionname:	<b>DS5 BER Hybrid4 Bus.GPS Plus 163PK Aut.</b>
First Registrationdate:	<b>16/10/2012</b>	Fiscalpower:	
Expertise Mileage:	<b>89607</b>	Power Kw:	<b>120</b>
Bodytype:	<b>Hatchback</b>	Body color:	<b>White</b>
Gearbox:	<b>Automatic</b>	Paint type:	<b>Opaque</b>
Transmission:	<b>Front</b>	Rims summer:	<b>Aluminium</b>
Fueltype:	<b>Diesel</b>	Oil level:	<b>OK</b>
Battery functioning:	<b>Yes</b>	Parking lot:	<b>4313</b>
Number of doors:	<b>5</b>		
Number of seats:	<b>5</b>		
Number head rests:	<b>5</b>		
Rims summer:	<b>Aluminium</b>		
Category:	<b>Passenger Car</b>		
Oil level:	<b>OK</b>

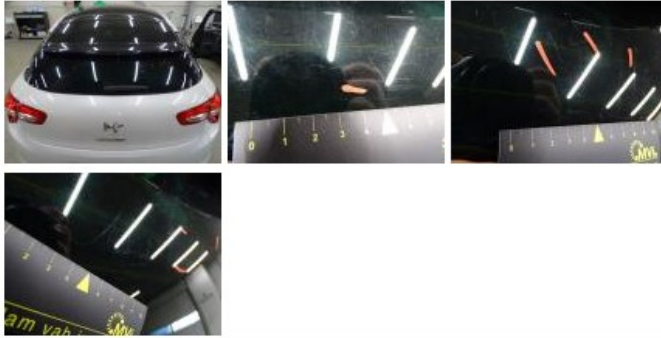
Rear window, Scratch(es), E - Replace 0,00

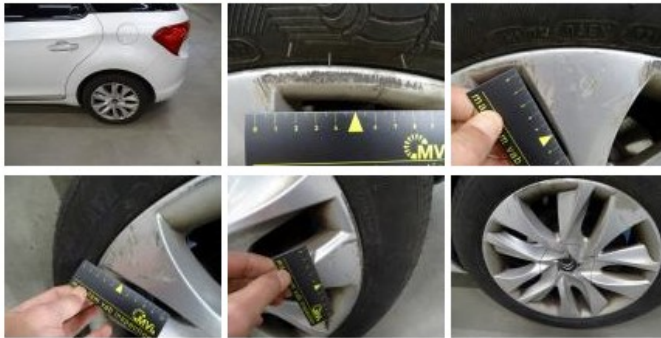
Alloy rim R L, Scratch(es), LI - Repair and paint (complete) 95,00

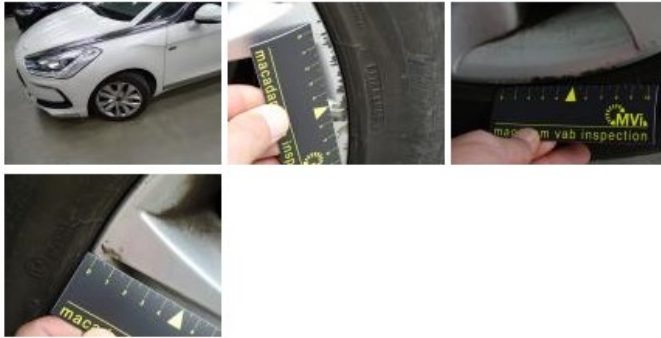
Alloy rim F L, Scratch(es), LI - Repair and paint (complete) 95,00

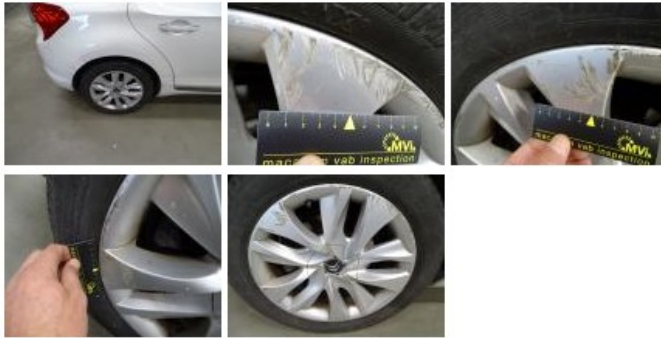
Alloy rim R R, Scratch(es), LI - Repair and paint (complete) 95,00
