MERCEDES C: 1GHI059

Vinnumber:	WDD2042021G263912	Versionname:	C BRE 220CDI BE Edition Avantgarde 163PK
First Registrationdate:	7/02/2014	Fiscalpower:	
Expertise Mileage:	59082	Power Kw:	120
Bodytype:	Break	Body color:	Grey
Gearbox:	MAN 6 VIT	Paint type:	Metalic
Transmission:	Back	Rims summer:	Aluminium
Fueltype:	Diesel	Oil level:	OK
Battery functioning:	Yes	Parking lot:	4404
Number of doors:	5		
Number of seats:	5		
Number head rests:	5		
Rims summer:	Aluminium		
Category:	Passenger Car		
Oil level:	OK		
Registration Certificate Car (BE):	Yes

Limited Technical Inspection

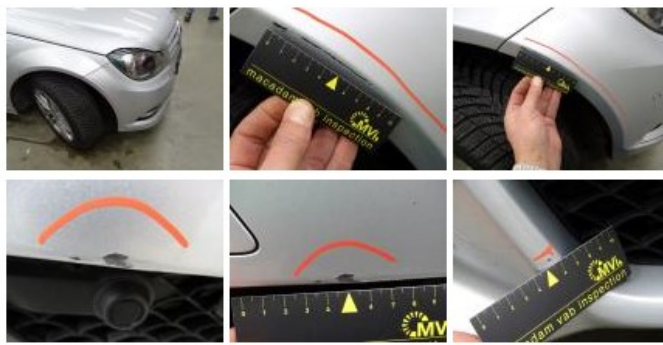
Door R L, Scratch(es), Acceptable	0,00
<i>No pictures to display</i>	
Front bumper, Scratch(es), LI - Repair and paint (complete)	211,80
