MERCEDES A: 1HVN948

Limited Technical Inspection

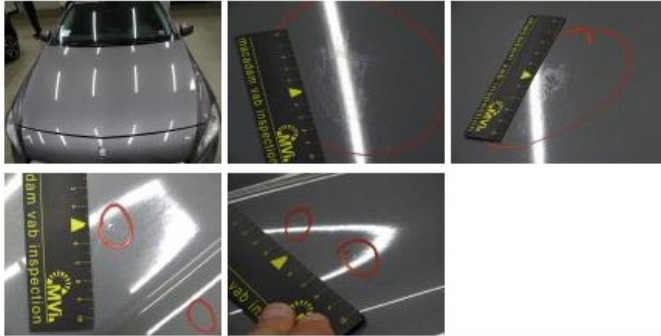
Bonnet, Chemical pollution, LI - Repair and paint (complete) 290,08

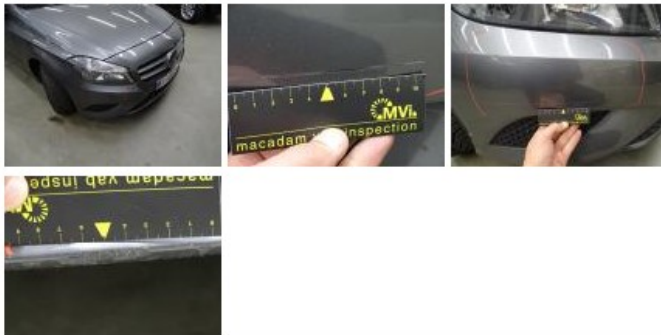
Front bumper, Scratch(es), LI - Repair and paint (complete) 211,80
