**PEUGEOT 5008: 1DHD493**

**Limited Technical Inspection**

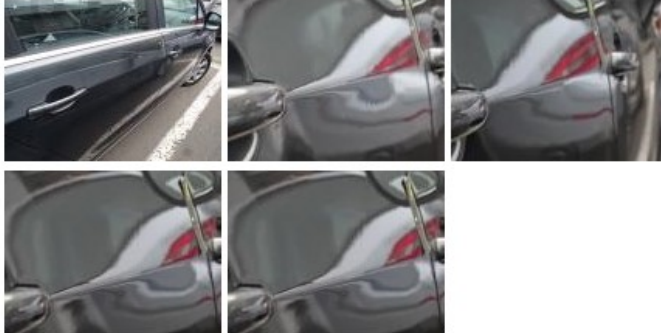
Door R R, Bad repair, Acceptable 0,00
