**SKODA Octavia: 1ETI049**

**Limited Technical Inspection**

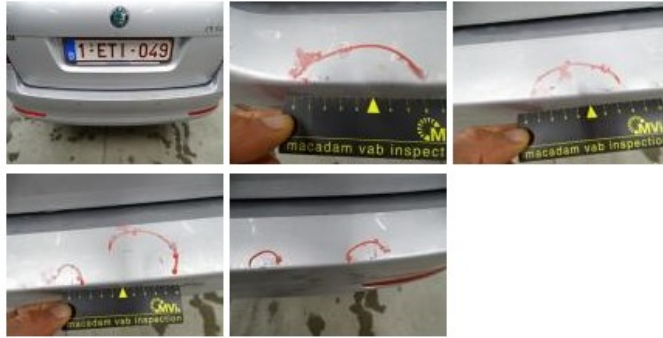
Bumper R, Scratch(es), LI - Repair and paint (complete) 211,80
