SKODA Superb: 1GHH147			
Vinnnumber:	TMBJJ73T6E9040540	Versionname:	SUPERB COMBI GreenLine Elegance 105PK
First Registrationdate:	7/02/2014	Fiscalpower:	
Expertise Mileage:	172230	Power Kw:	77
Bodytype:	Break	Body color:	Black
Gearbox:	MAN 6 VIT	Paint type:	Metalic
Transmission:		Rims summer:	Aluminium
Fueltype:	Diesel	Oil level:	OK
Battery functioning:	Yes	Parking lot:	3410
Number of doors:	5		
Number of seats:	5		
Number head rests:	5		
Rims summer:	Aluminium		
Category:	Passenger Car		
Oil level:	OK		
Registration Certificate Car (BE):	Yes

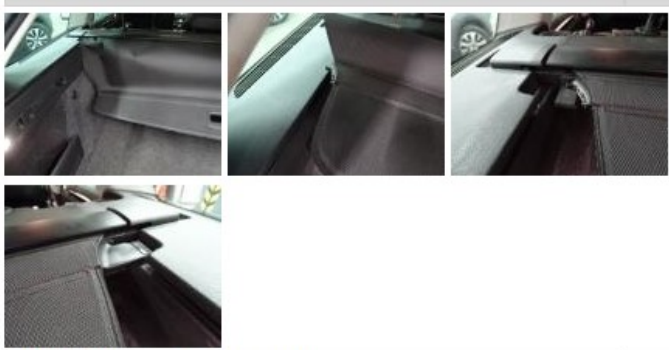
Assistance equipment			
Repair kit	Yes	Compressor	Yes
Total cost ex VAT			1604,96
Luggage space cover, Damaged, E - Replace			288,00

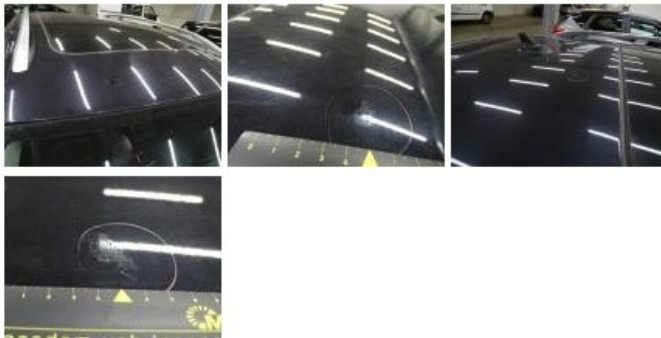
Roof, Chemical pollution, LI - Repair and paint (complete) 577,80

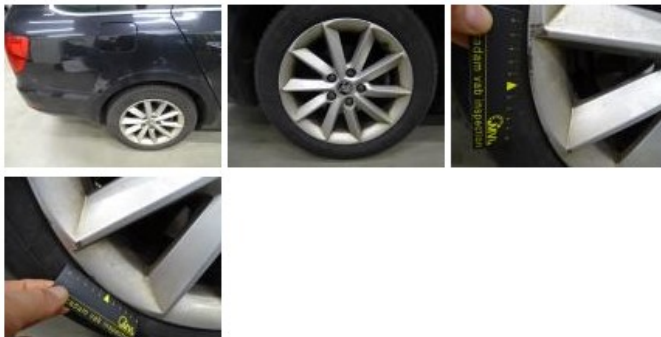
Alloy rim R R, Scratch(es), LI - Repair and paint (complete) 95,00
