SKODA OCTAVIA COMBI: BB8968

Limited Technical Inspection

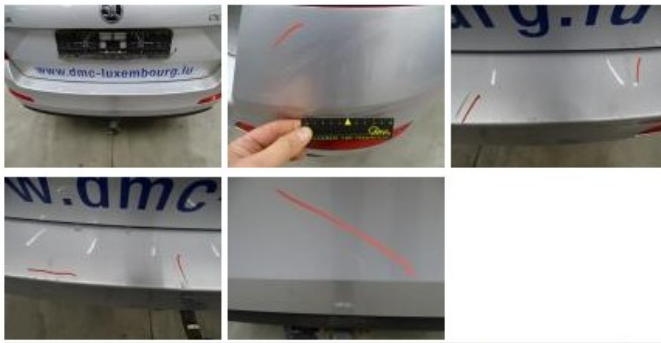
Bumper R, Scratch(es), LI - Repair and paint (complete) 211,80

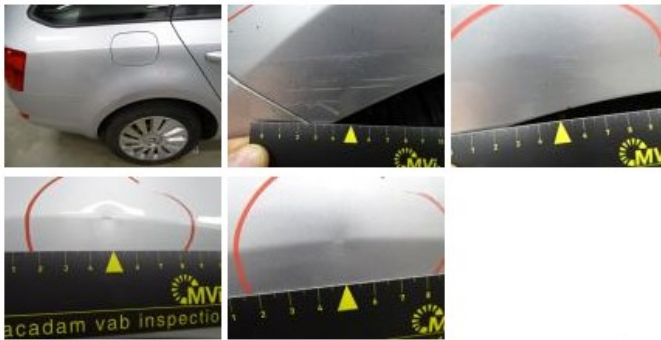
Wing R R, Bump(s) and scratch(es), LI - Repair and paint (complete) 308,20
