<b>SKODA Octavia: 1EUI360</b>			
Vinnumber:	<b>TMBHT21Z9D2136995</b>	Versionname:	<b>OCTAVIA COMBI GTec Ambition DPF 105PK</b>
First Registrationdate:	<b>22/03/2013</b>	Fiscalpower:	
Expertise Mileage:	<b>110533</b>	Power Kw:	<b>77</b>
Bodytype:	<b>Break</b>	Body color:	<b>Beige</b>
Gearbox:	<b>MAN 5 VIT</b>	Paint type:	<b>Metalic</b>
Transmission:		Rims summer:	<b>Aluminium</b>
Fueltype:	<b>Diesel</b>	Oil level:	<b>OK</b>
Battery functioning:	<b>Yes</b>	Parking lot:	<b>1428</b>
Number of doors:	<b>5</b>		
Number of seats:	<b>5</b>		
Number head rests:	<b>5</b>		
Rims summer:	<b>Aluminium</b>		
Category:	<b>Passenger Car</b>		
Oil level:	<b>OK</b>

<b>Limited Technical Inspection</b>			
Power steering	<b>Yes</b>	Battery functioning	<b>Yes</b>
Airco functioning	<b>OK</b>	Sound engine	<b>OK</b>
Tires wear profile	<b>OK</b>	Clutch test	<b>OK</b>
Idle position	<b>OK</b>	Wiper fluid level	<b>OK</b>
Engine startingtime	<b>OK</b>	Lighting	<b>OK</b>
Exhaust gass	<b>OK</b>	Wiperblades	<b>OK</b>
Transmission	<b>OK</b>		
Handbrake	<b>OK</b>

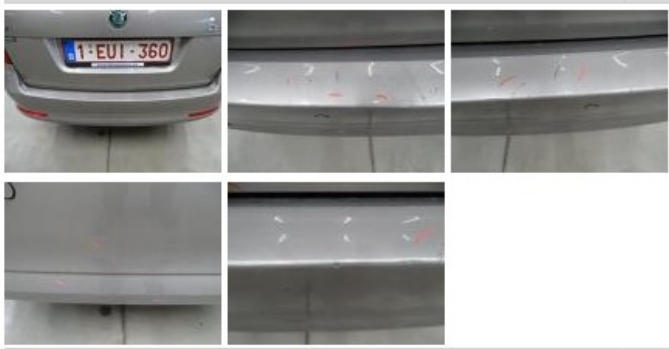
<b>Assistance equipment</b>			
Spare wheel	<b>Yes</b>	Jack	<b>Yes</b>
Total cost ex VAT			<b>866,35</b>
Bumper R, Scratch(es), LI - Repair and paint (complete)			<b>211,80</b>
