FIAT Ducato 35 LWB HHR: 1AHW710

Limited Technical Inspection

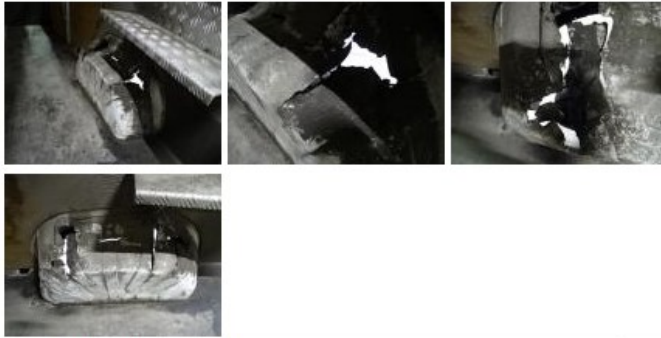
Wheel aperture R R, Rust, Le - Replace and paint 296,00

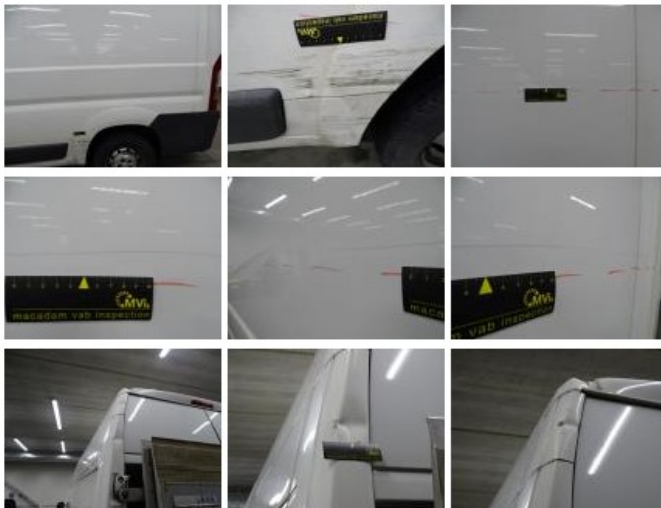
Wing R L, Bump(s) and scratch(es), LI - Repair and paint (complete) 231,15
