BMW 3: 1GK1132

Limited Technical Inspection

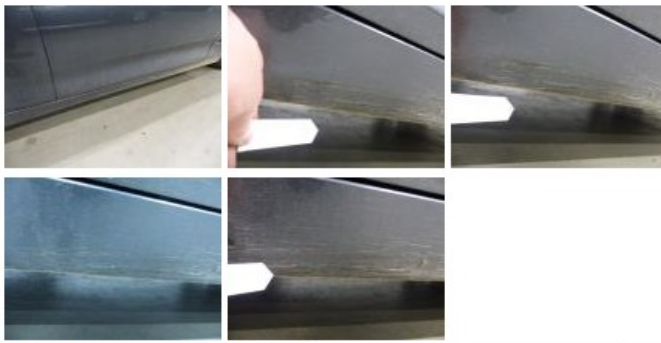
Sill outer R, Scratch(es), LI - Repair and paint (complete)	310,50
---	--------

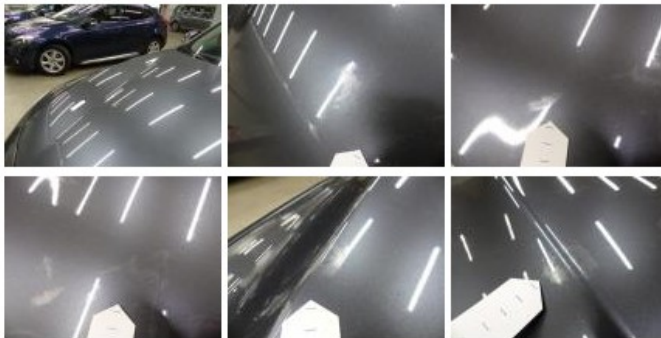
Alloy rim F R, Scratch(es), Acceptable	0,00
<i>No pictures to display</i>	
Alloy rim R R, Scratch(es), Acceptable	0,00
<i>No pictures to display</i>	
Bonnet, Chemical polution, LI - Repair and paint (complete)	290,08

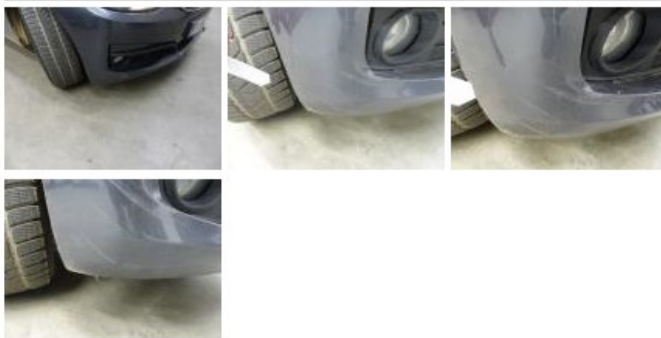
Wing R R, Scratch(es), Acceptable	0,00
<i>No pictures to display</i>	
Door F L, Scratch(es), Acceptable	0,00
<i>No pictures to display</i>	
Roof, Chemical polution, Acceptable	0,00
<i>No pictures to display</i>	
Bumper R, Scratch(es), Acceptable	0,00
<i>No pictures to display</i>	
Front bumper, Scratch(es), LI - Repair and paint (complete)	211,80
