OPEL Astra: 1CBI345			
Vinnnumber:	<b>WOLPE8EF0C8014268</b>	Versionname:	<b>ASTRA BRE Cosmo FAP 125PK</b>
First Registrationdate:	<b>11/10/2011</b>	Fiscalpower:	
Expertise Mileage:	<b>191119</b>	Power Kw:	<b>92</b>
Bodytype:	<b>Break</b>	Body color:	<b>Grey</b>
Gearbox:	<b>MAN 6 VIT</b>	Paint type:	<b>Metalic</b>
Transmission:	<b>Front</b>	Rims summer:	<b>Aluminium</b>
Fueltype:	<b>Diesel</b>	Oil level:	<b>OK</b>
Maintenance:	<b>MOET GEDAAN WORDEN</b>	Parking lot:	<b>3826</b>
Maintenance:	<b>NOT OK</b>		
Battery functioning:	<b>Yes</b>		
Number of doors:	<b>5</b>		
Number of seats:	<b>5</b>		
Number head rests:	<b>4</b>		
Rims summer:	<b>Aluminium</b>		
Category:	<b>Passenger Car</b>		
Oil level:	<b>OK</b>

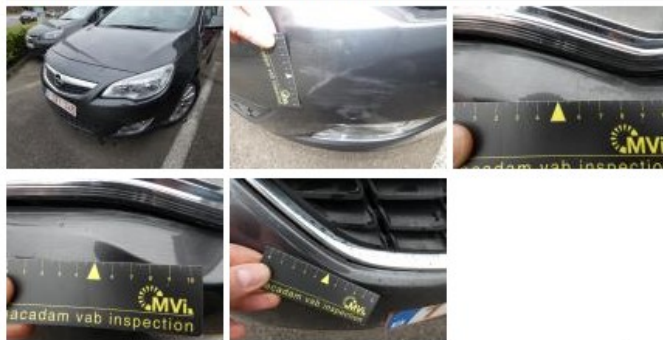
<i>No pictures to display</i>	
Wing R R, Bump(s), Acceptable	0,00
<i>No pictures to display</i>	
Trunk lid covering R, Scratch(es), Acceptable	0,00
<i>No pictures to display</i>	
Front bumper, Scratch(es), LI - Repair and paint (complete)	259,80

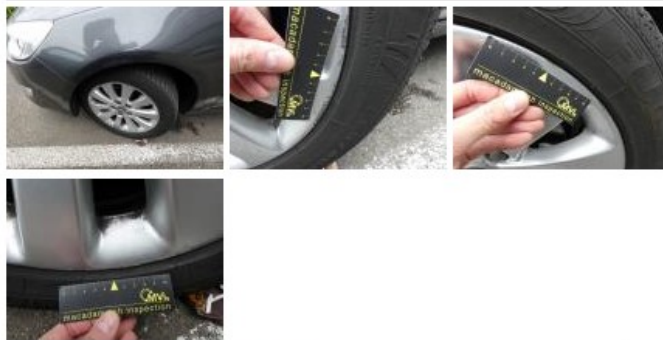
Alloy rim F L, Scratch(es), LI - Repair and paint (complete)	95,00
--	-------

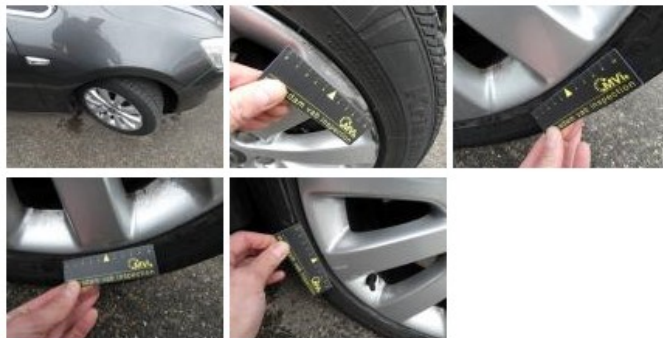
<i>No pictures to display</i>	
Alloy rim F R, Scratch(es), LI - Repair and paint (complete)	95,00
