VOLVO V60: 1EFJ121			
Vinnumber:	YV1FW84A1D1116625	Versionname:	V60 D2 Base St/St 115PK
First Registrationdate:	15/11/2012	Fiscalpower:	
Expertise Mileage:	176915	Power Kw:	84
Bodytype:		Body color:	Grey
Gearbox:	MAN 6 VIT	Paint type:	Metalic
Transmission:	Front	Rims summer:	Aluminium
Fueltype:	Diesel	Oil level:	OK
Maintenance:	UITVOEREN	Parking lot:	2230
Maintenance:	NOT OK		
Battery functioning:	Yes		
Number of doors:	5		
Number of seats:	5		
Number head rests:	5		
Rims summer:	Aluminium		
Category:	Passenger Car		
Oil level:	OK

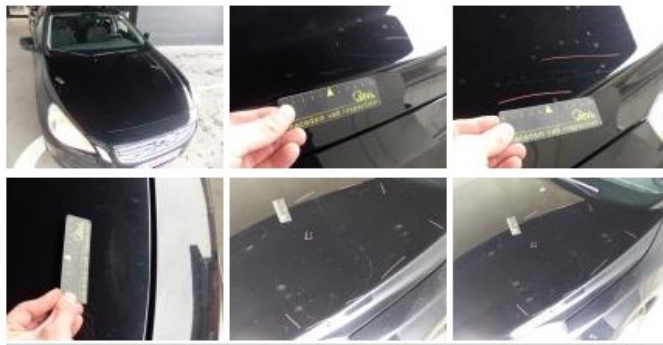
Bonnet, Scratch(es), LI - Repair and paint (complete)	0,00
---	-------------

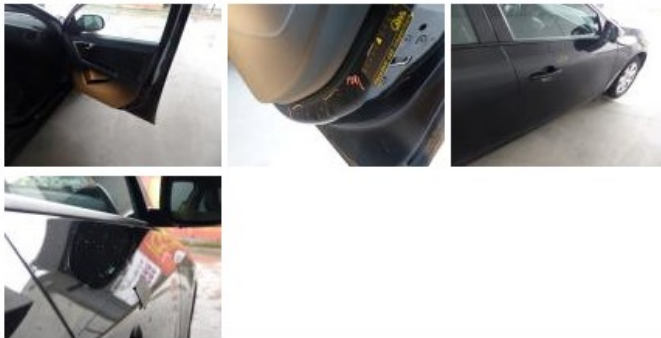
Door F R, Bump(s), PDR - Knock out without painting 142,20

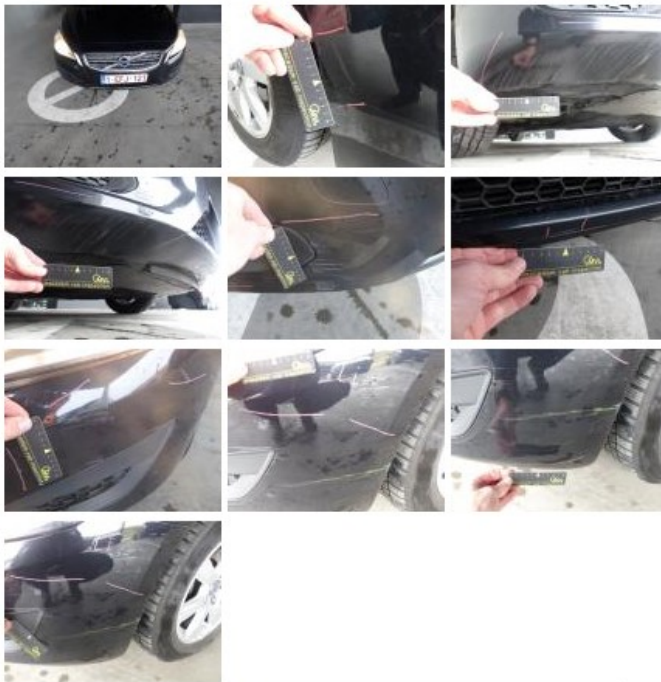
Front bumper, Damaged, Le - Replace and paint 0,00

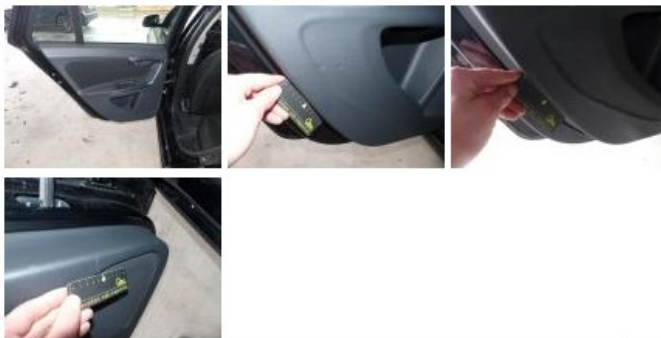
Door panel R L, Damaged, E - Replace 114,00

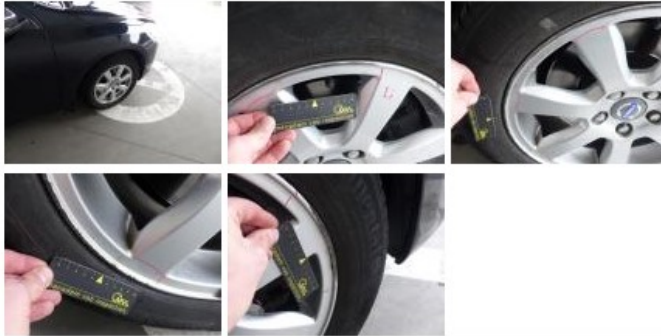
Alloy rim F R, Scratch(es), LI - Repair and paint (complete) 95,00
